- FORGE POND DAM & DIKE-
PHASE I
INSPECTION / EVALUATION REPORT

Dam Name: Forge Dam & Dike
State Dam ID#: 2-8-111-2 Dam & 2-8-111-3 Dike
NID#: MA00488 Dam & MA00489 Dike
Owner: Town of Granby
Owner Type: Municipal
Town: Granby
Consultant: Lenart Consulting Service, LLC
Date of Inspection: March 23, 2020

Executive Summary

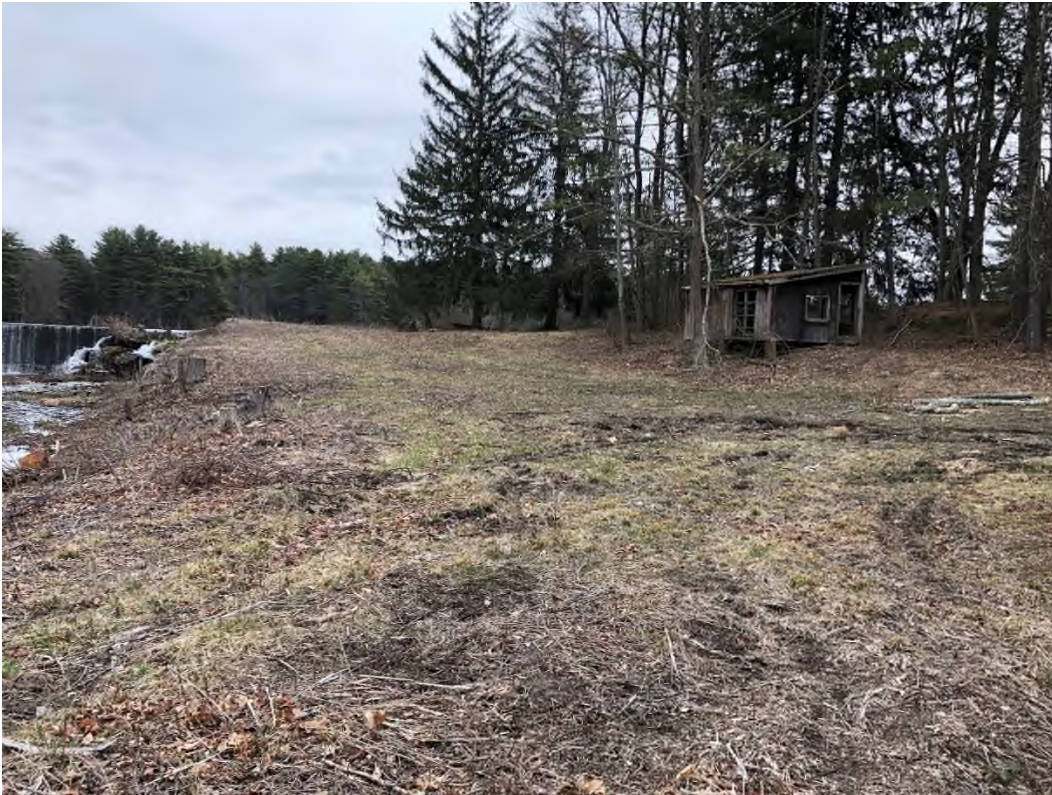
Photo 1 – Downstream view of embankment left of spillway

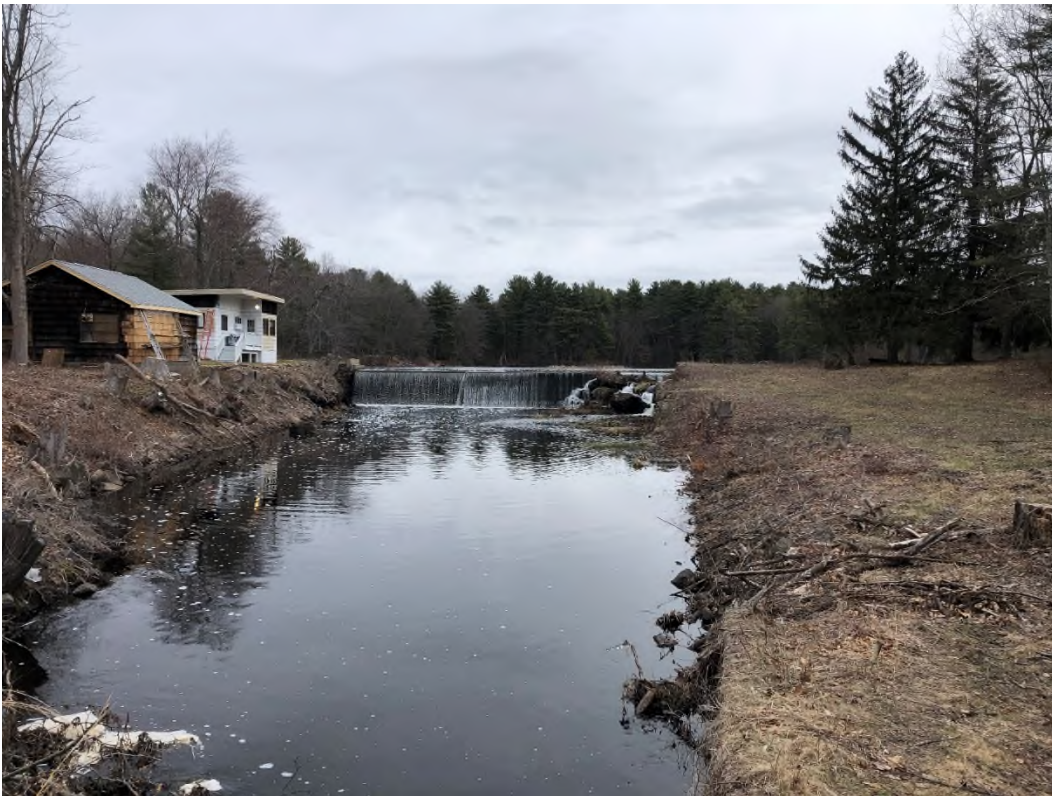
Photo 2 – Downstream overview of dam

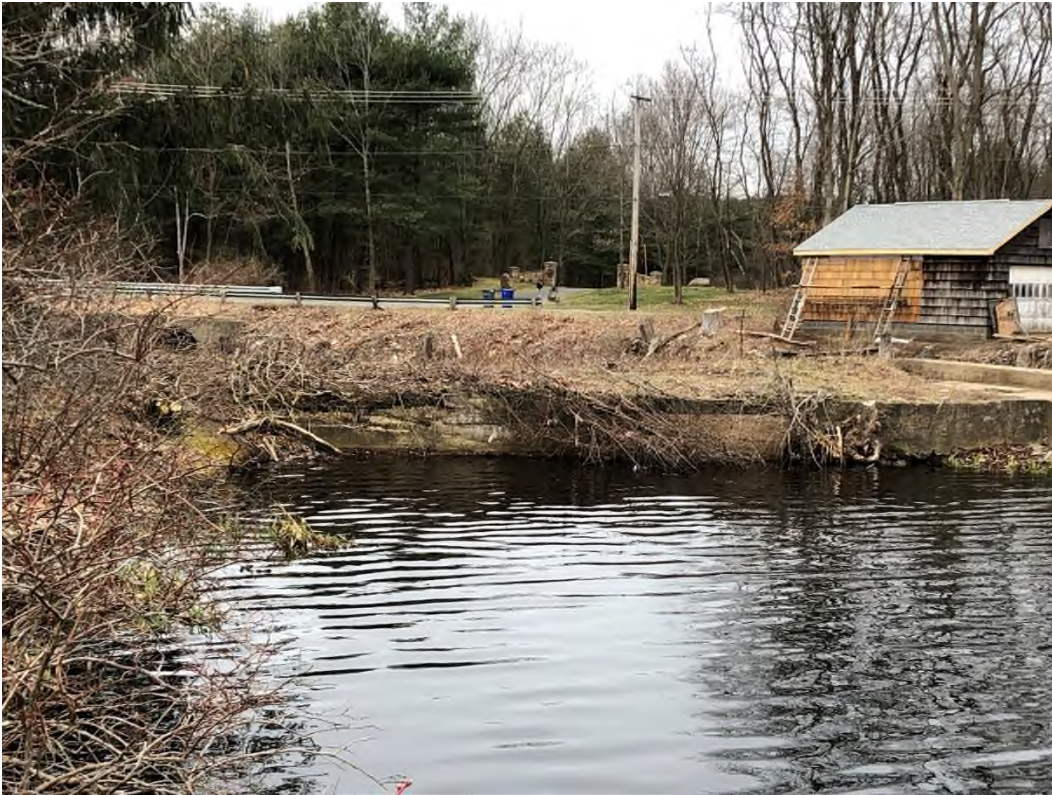
- Contact at the left abutment appears good. Outcroppings of bedrock are visible upstream at the abutment.
- Upstream slope
 - There is a concrete wall at the upstream face of the embankment to the left of the spillway. This wall appears to be in fair condition with horizontal and vertical cracks and spalled areas on the vertical face.

Photo 3 – Upstream view of embankment retaining wall cracks and spalling

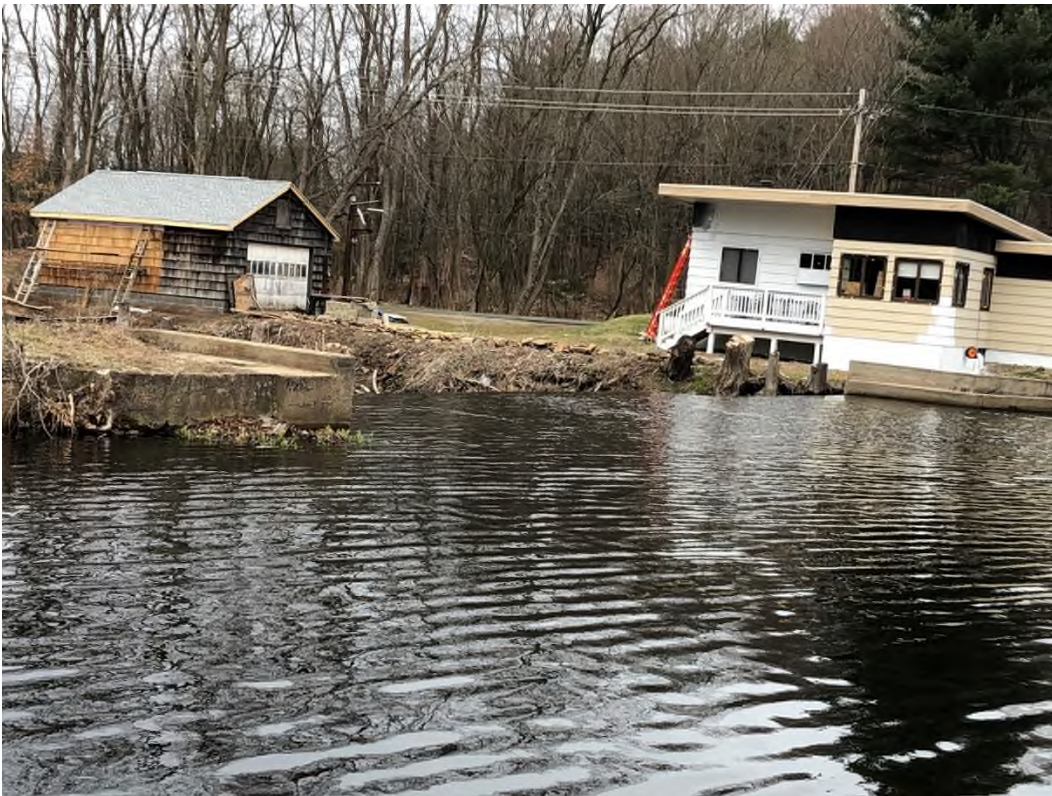
Photo 4 – Upstream view of spillway from left abutment

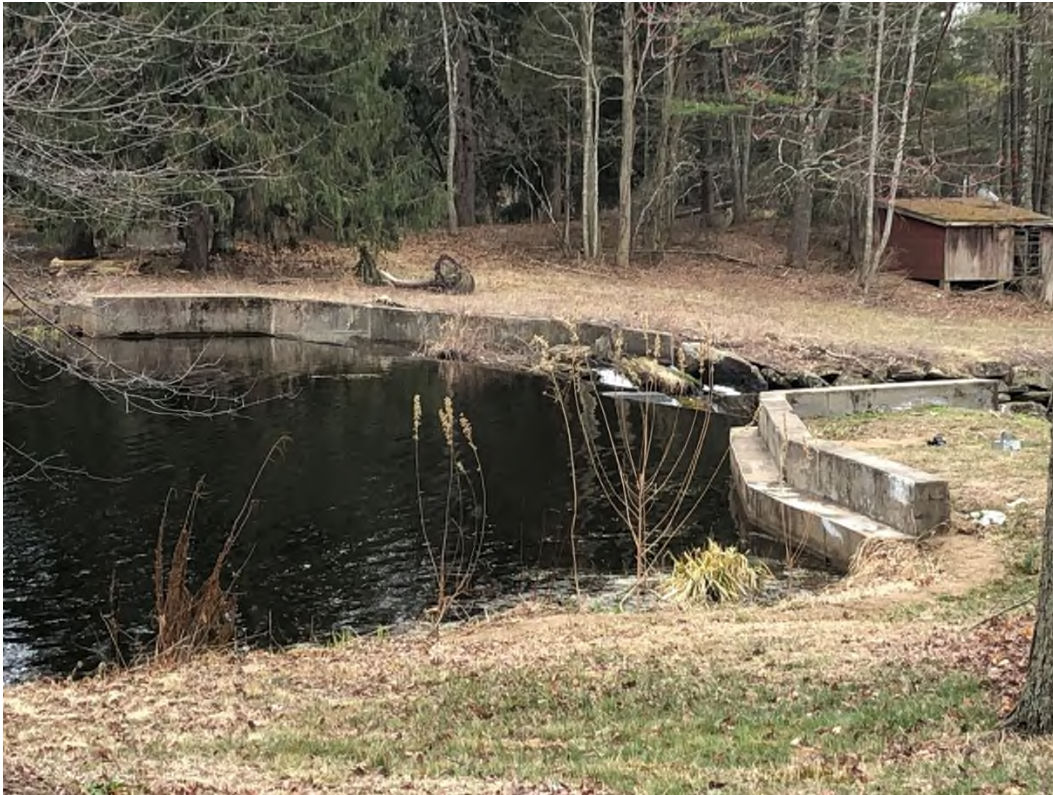
Photo 5 – Upstream overview from right side

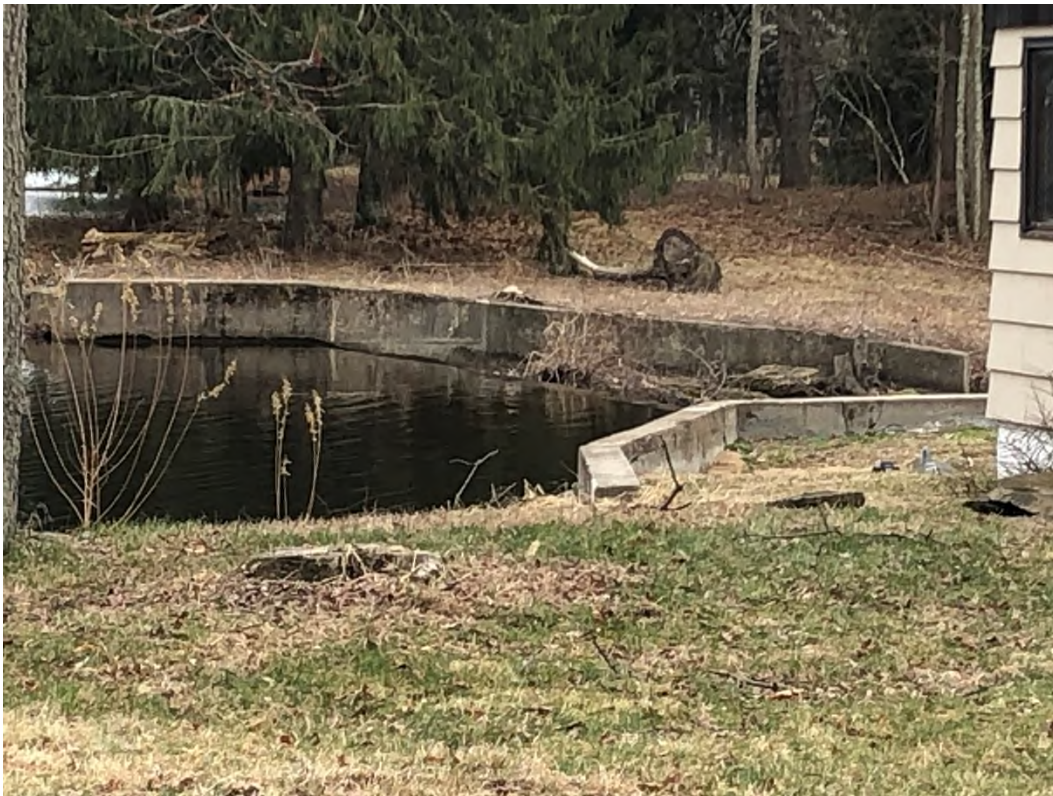
Photo 6 – Spillway and right training wall viewed from right side

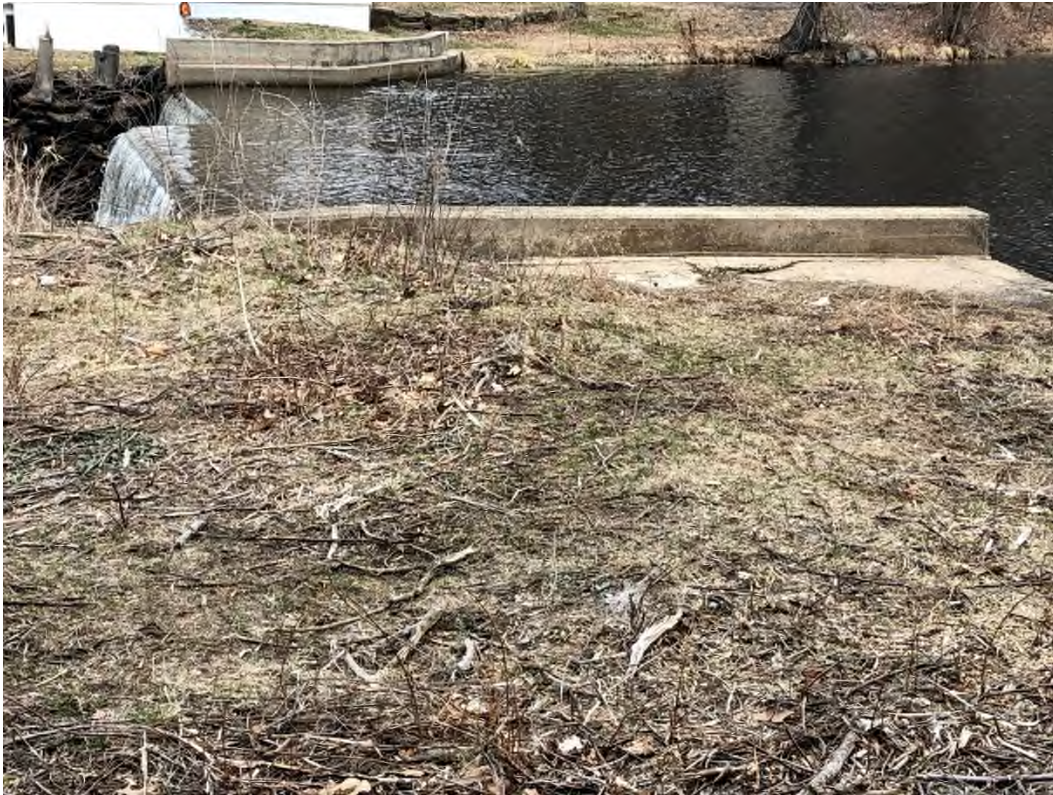
Photo 7 – Back of left training wall and spillway crest viewed from left side

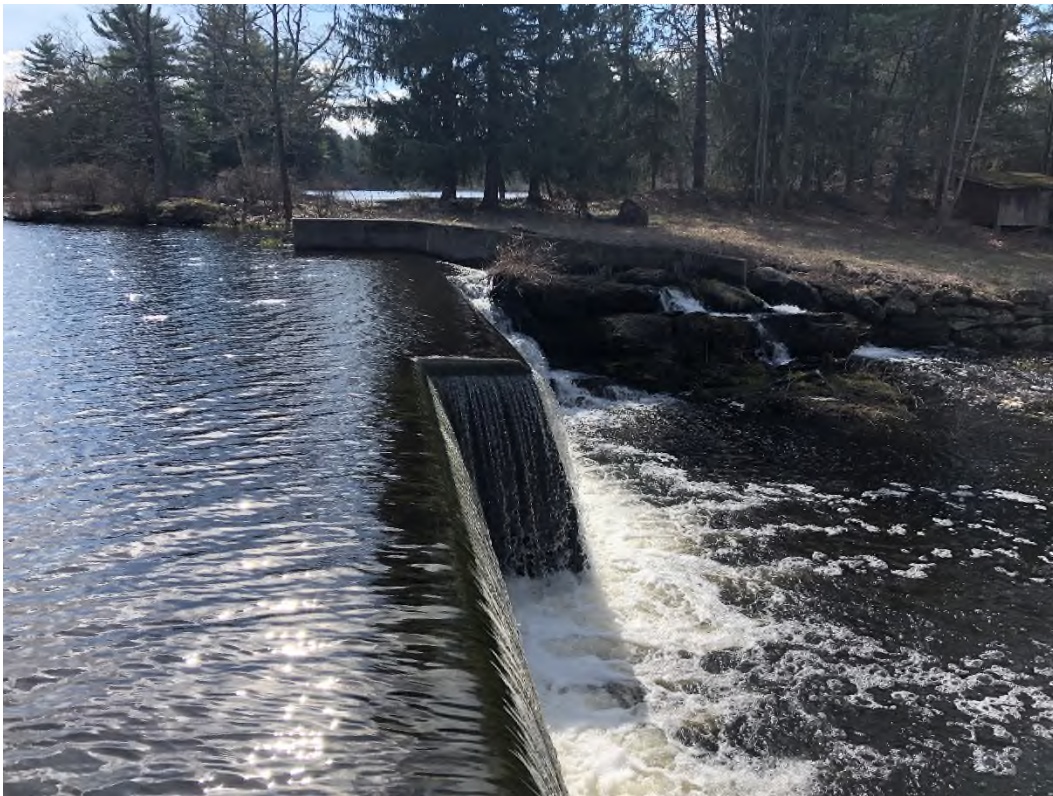
- The left concrete training wall has a vertical crack where a tree was growing at its base on the upstream side and spalling was observed near the top of the wall close to the spillway and along the normal pool waterline.

Photo 8 – Left training wall viewed from right side

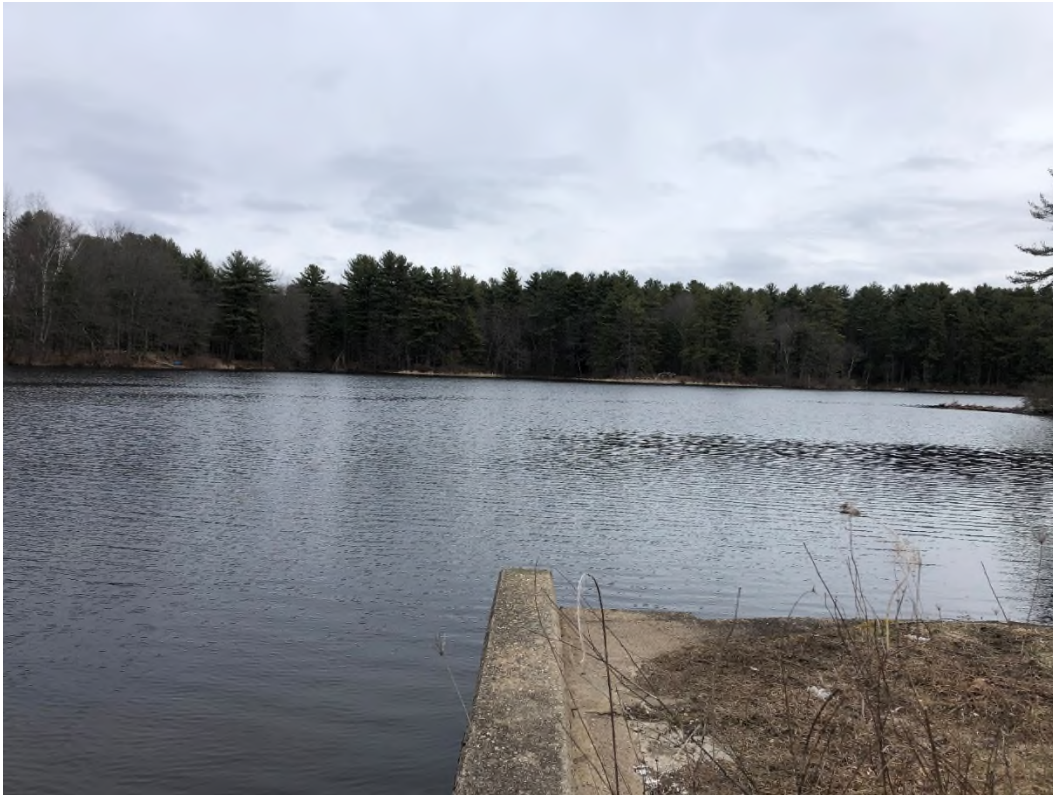
Photo 9 – View of impoundment and left upstream spillway training wall

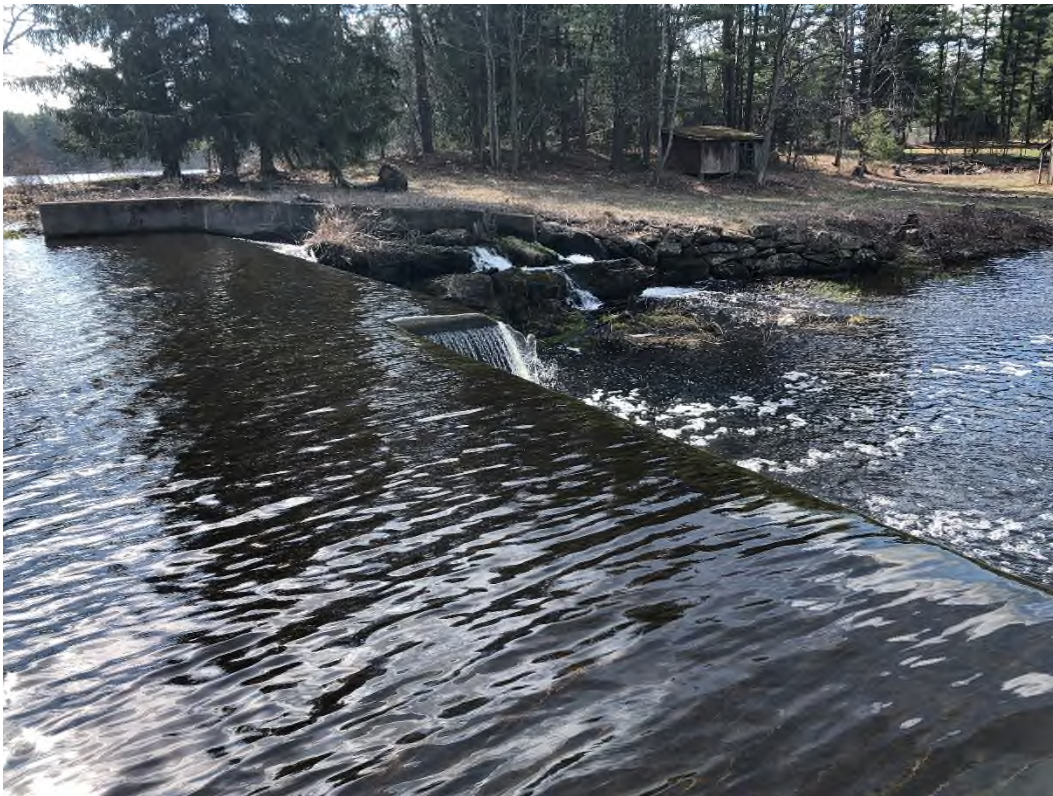
Photo 10 – View of jogged spillway crest and downstream area

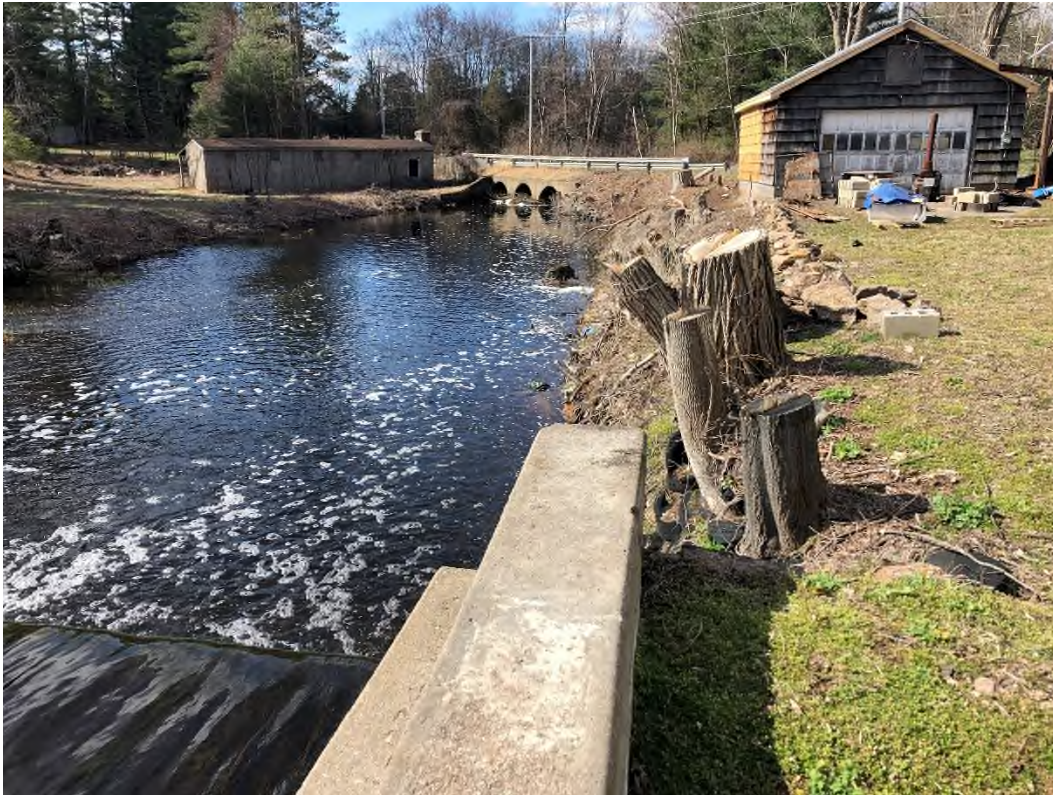
Photo 11 – Right upstream training wall and tree stumps downstream of spillway at right abutment.

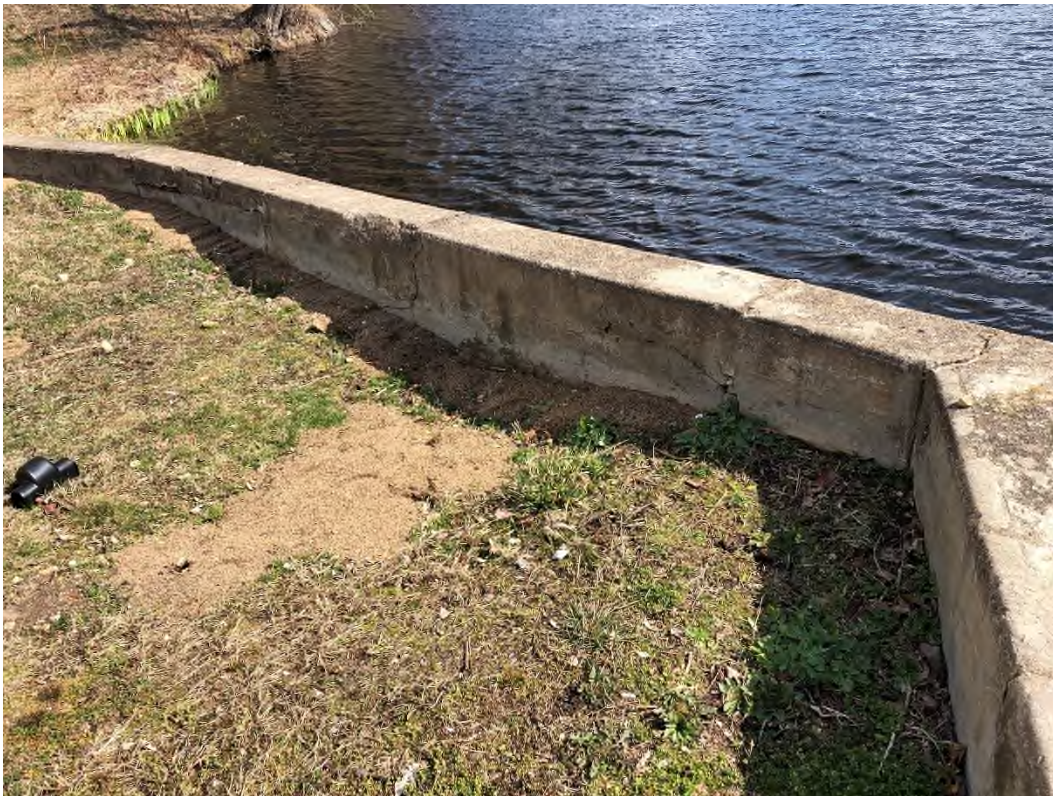
- Abutments
 - The right abutment of the main dam consists of a low concrete gravity wall on the upstream side, a portion of which was rebuilt in 1978. The settled area approximately 3 feet square and 1 foot deep noted in the 2014 inspection, located behind the right training wall of the spillway appears unchanged. This settled area was also noted during the 2009 and 1981 inspections.

Photo 12 – Settlement and rotting stump behind right upstream spillway training wall

1. Remove tree stumps and root systems.
2. Repair left concrete walls at the dam.
3. Fill the depressed area behind the spillway training wall at the right abutment.
4. Plant an erosion resistant surface on dam crest where soils are exposed.

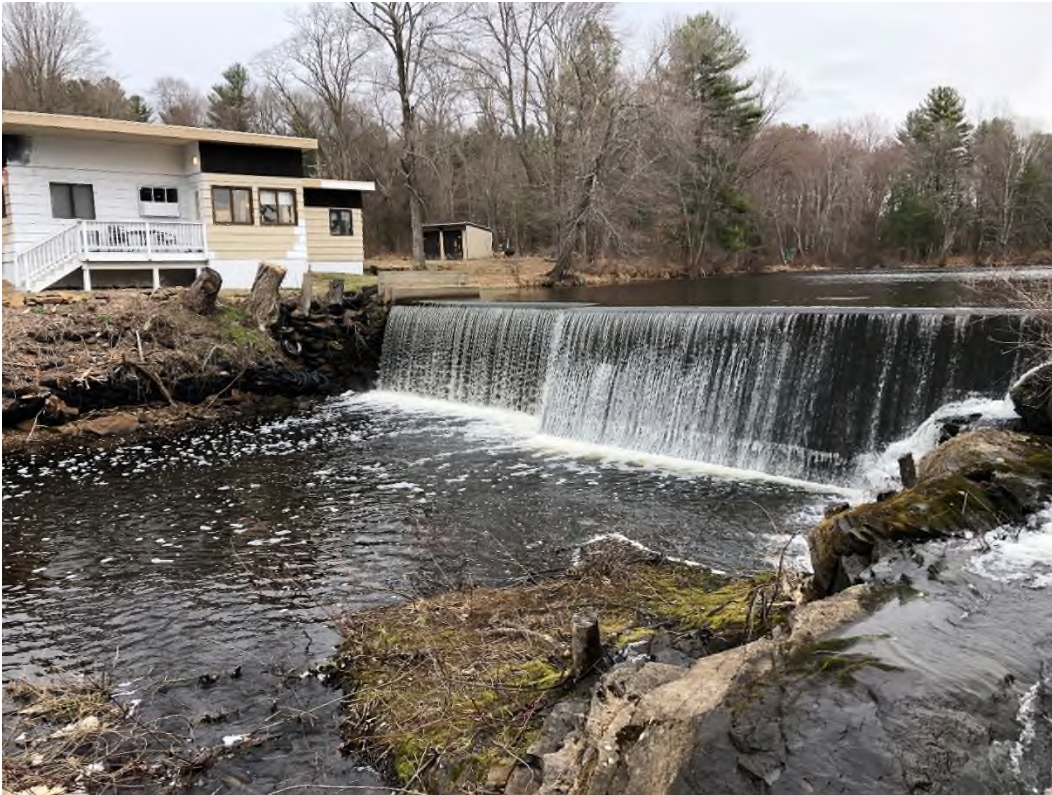
Photo 13 – Downstream side of spillway viewed from left side

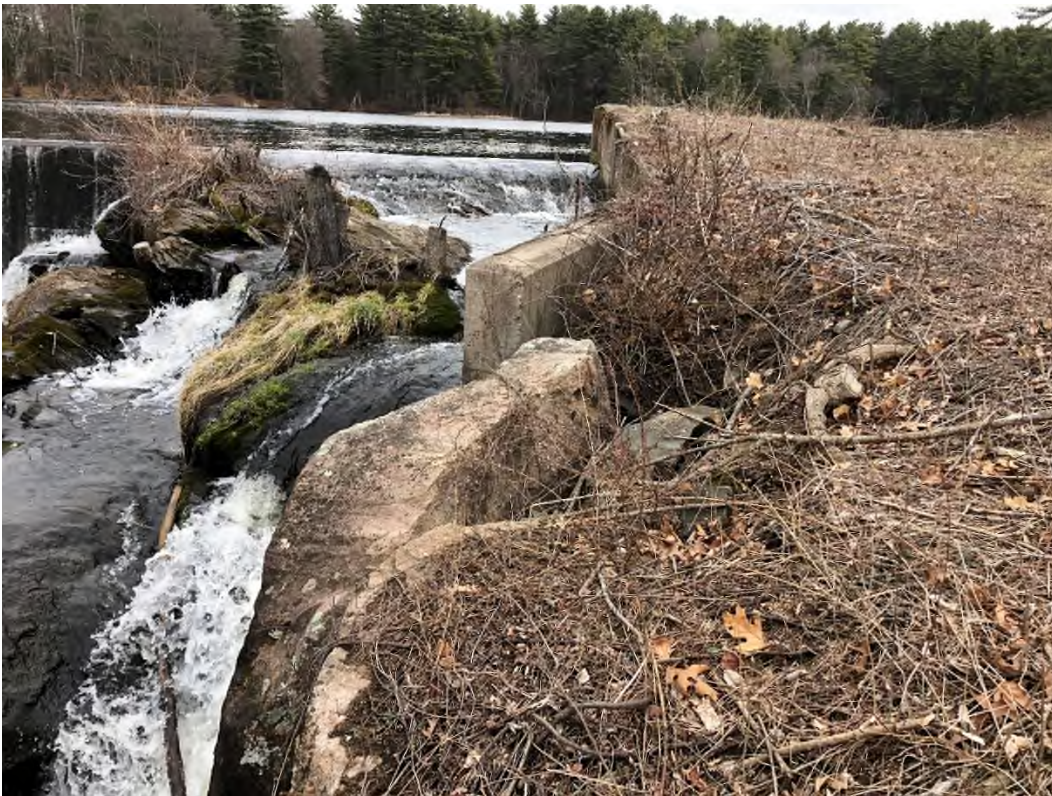
- Erosion of the gravelly soils has occurred behind the left spillway training wall at its downstream end. The undermining of the backfill material at this location was noted in the previous report where there are large gaps between the end of the wall and the boulders placed at the end of the wall has not changed significantly.

- The downstream extension of the left training wall consists of boulders. These boulders are founded on bedrock. Large gaps where the boulders meet the concrete wall are allowing water to erode the embankment materials behind the wall.

Photo 14 – Left side of spillway with erosion behind left downstream training wall

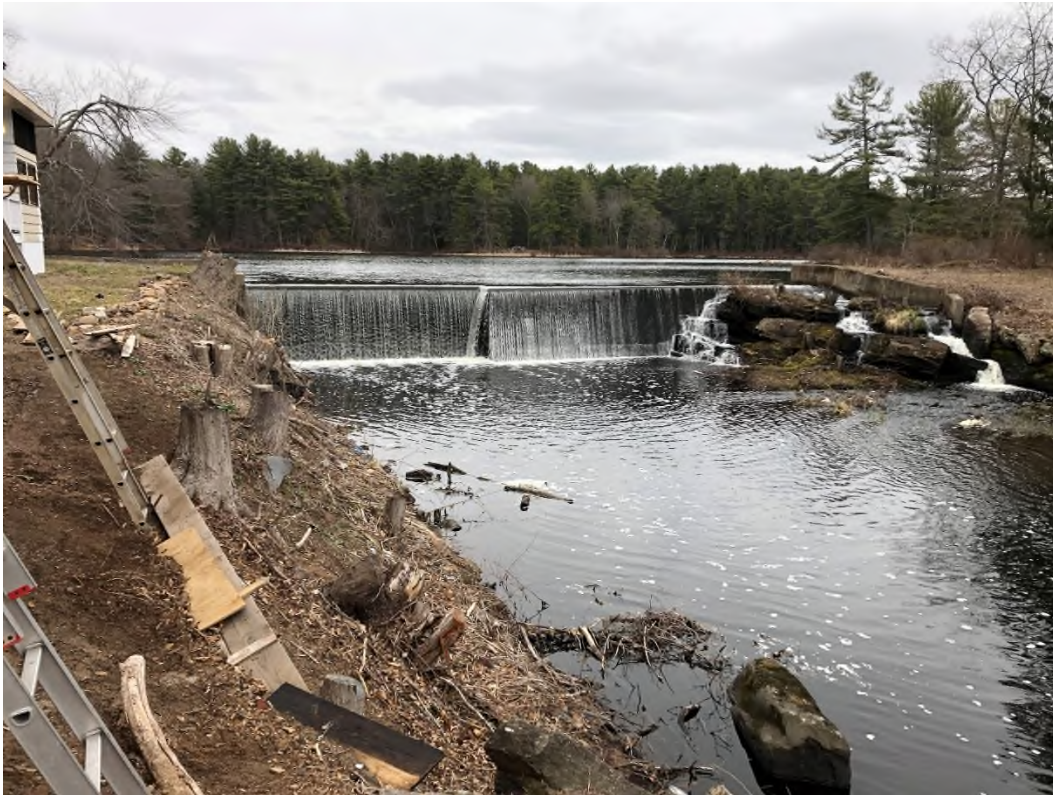
Photo 15 – Downstream view of spillway from right side

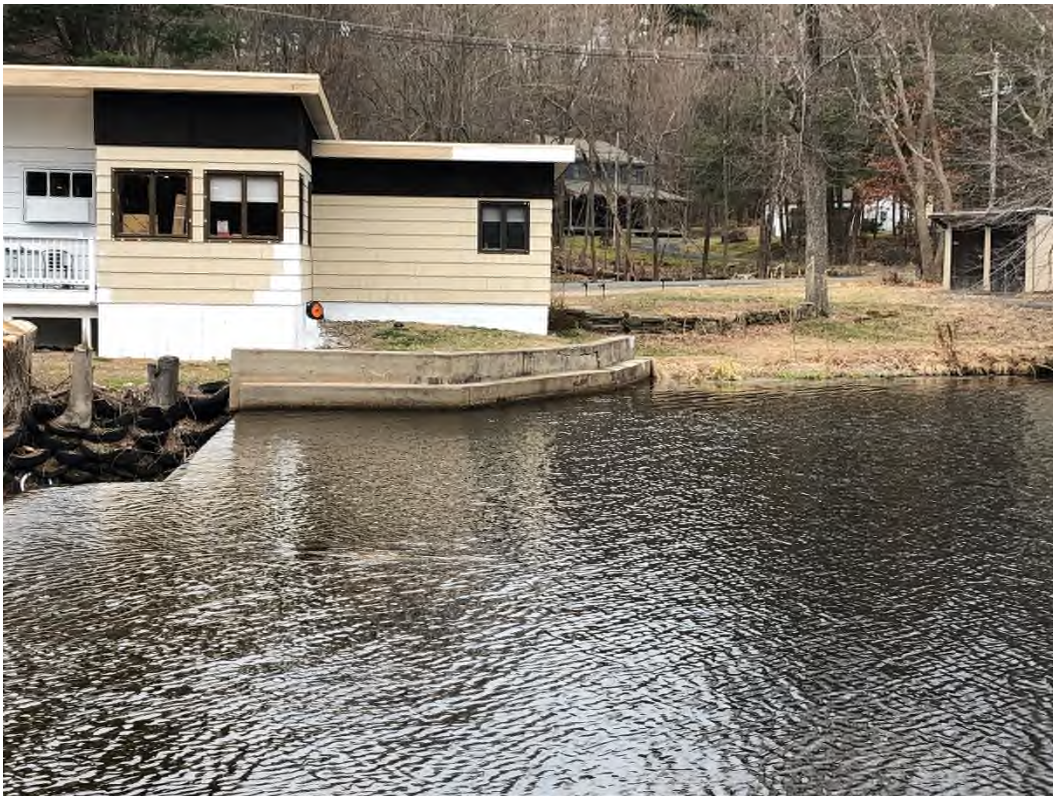
Photo 16 – Spillway crest, deteriorating concrete on right training wall and upstream retaining wall

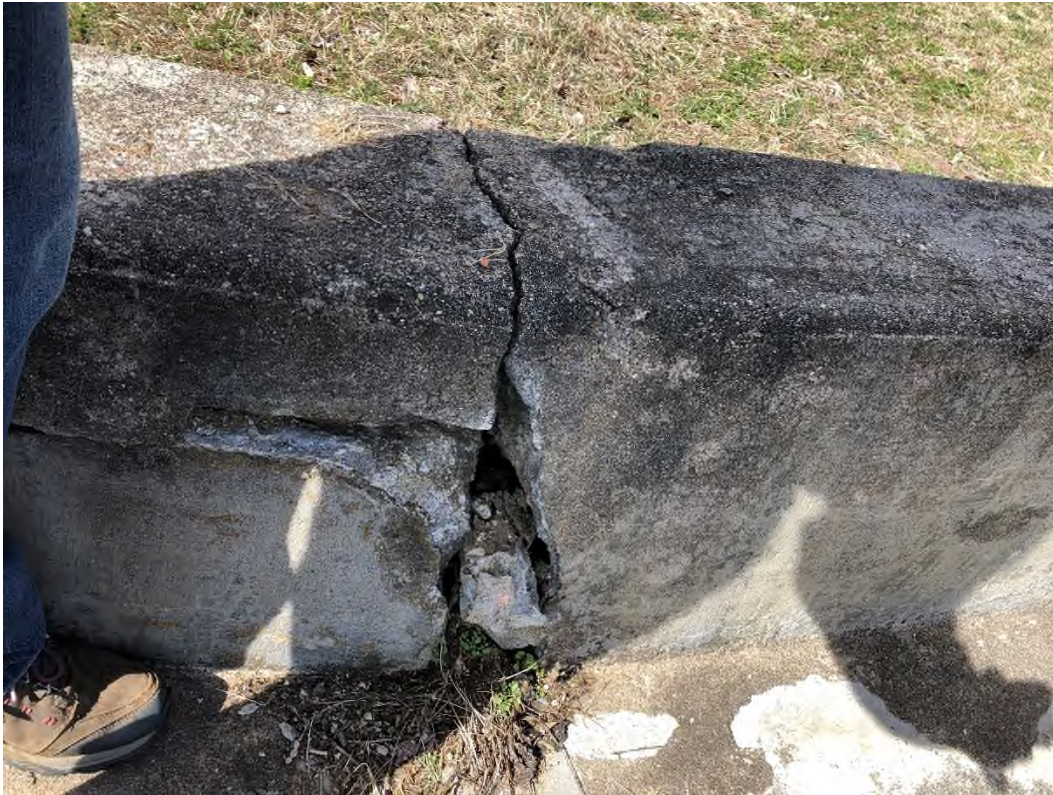
- The right upstream training wall, also the upstream face at the right abutment, has horizontal and vertical transverse cracks in the wall. Pieces of concrete have fallen loose from the wall in two areas. There are no cracks in the footing.

Photo 17 - Deteriorating concrete on upstream face of right spillway training wall

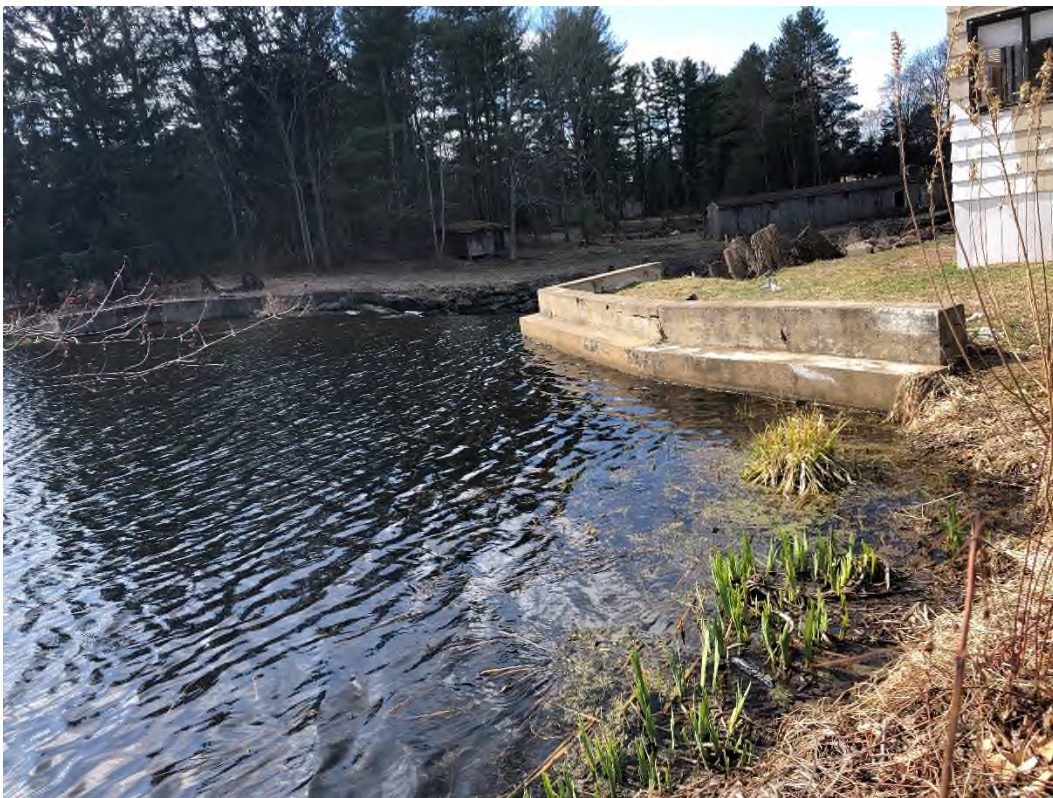
Photo 18 –Upstream face of right spillway training wall

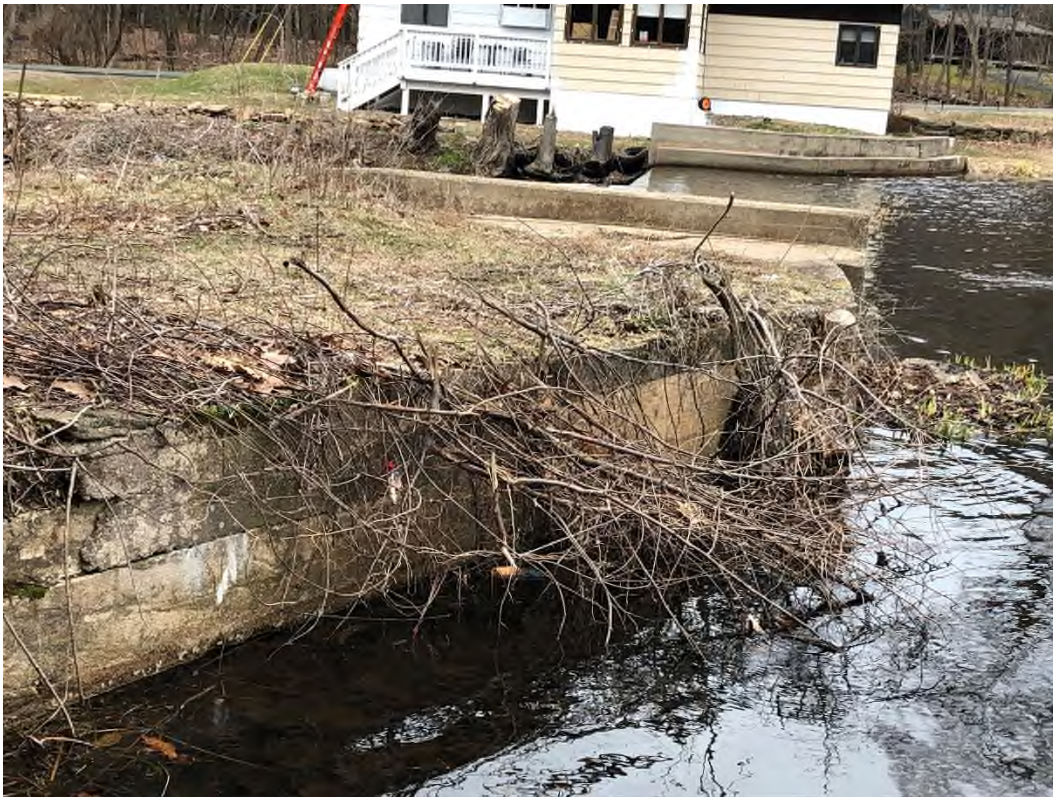
Photo 19 – Upstream left retaining wall

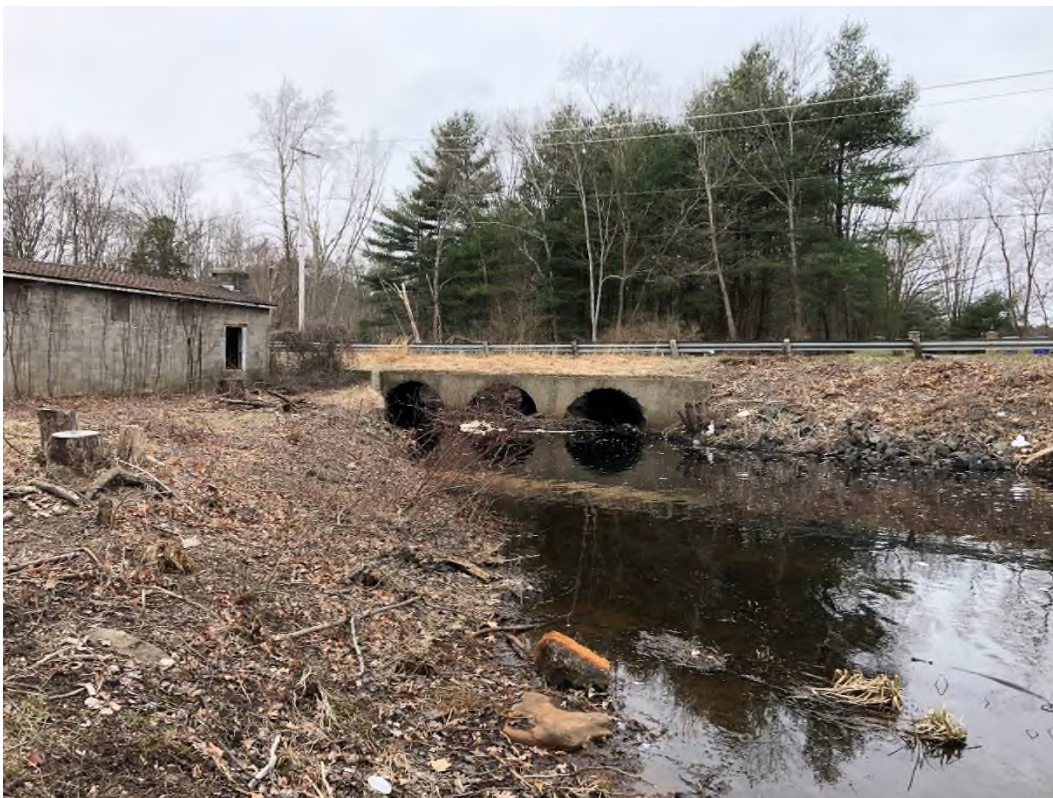
Photo 20 – Upstream view of ACCMP culverts passing under School Street downstream

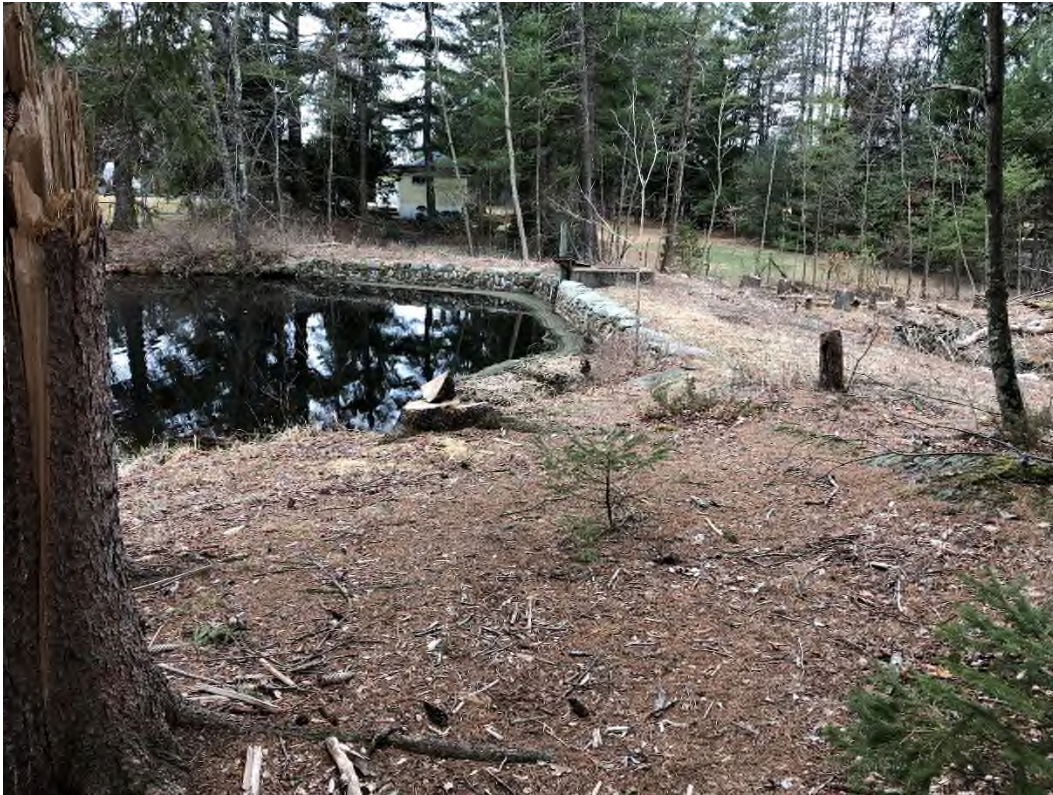
Photo 1 – Overview of upstream face of dike from right abutment

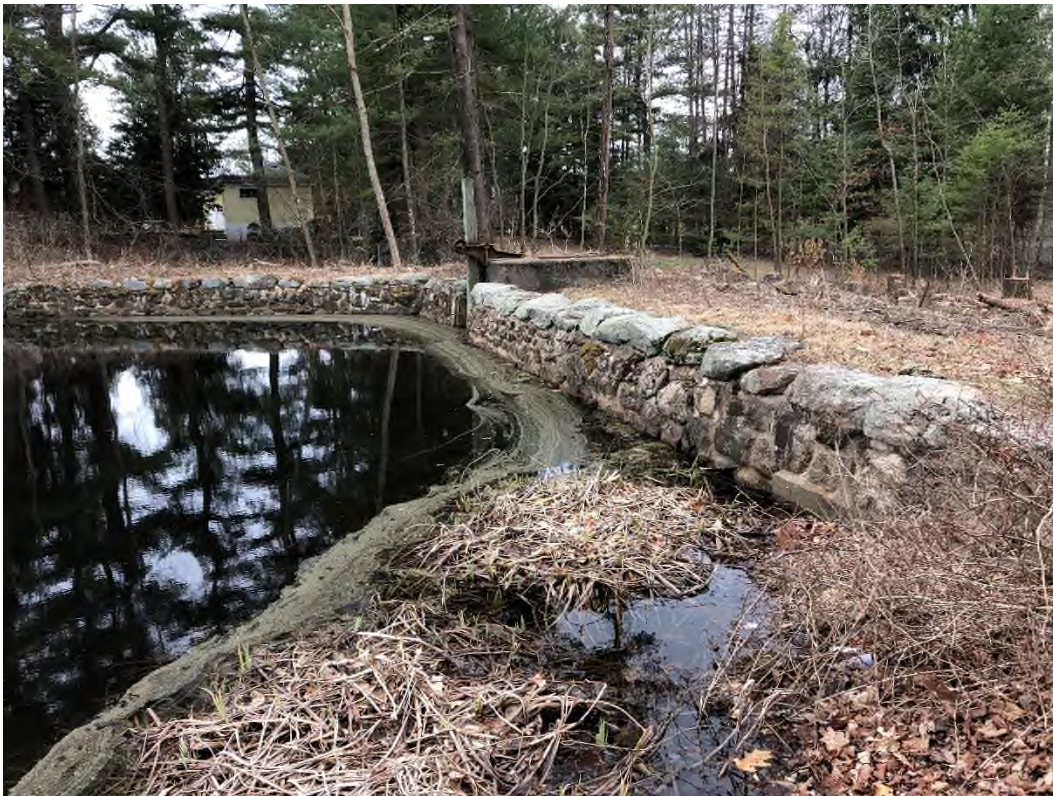
Photo 2 – Upstream face viewed from right end of dike

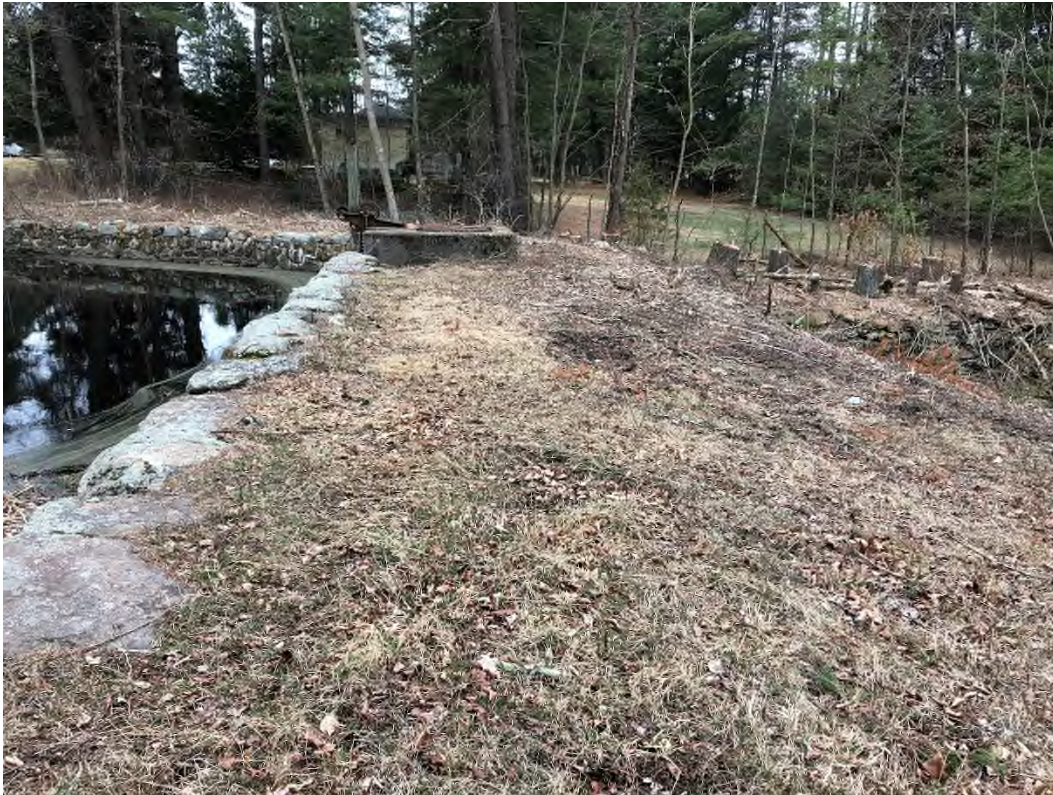
Photo 3 – Dike crest viewed from right end

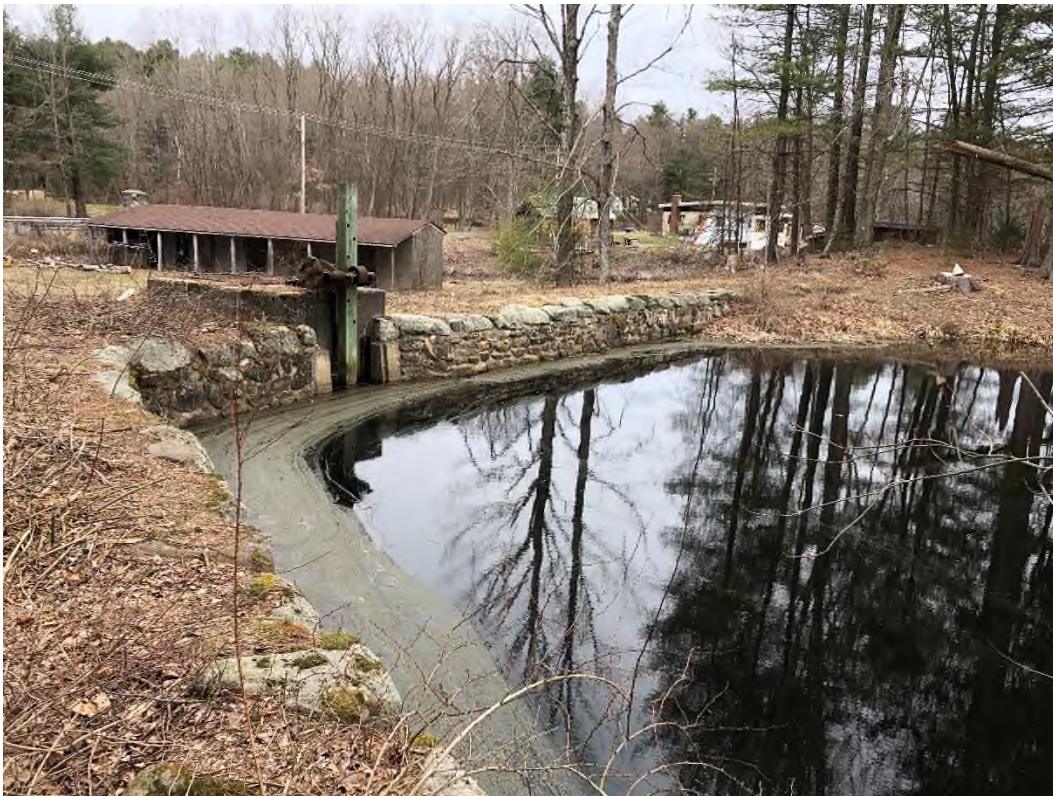
Photo 4 – Upstream face of dike from left abutment

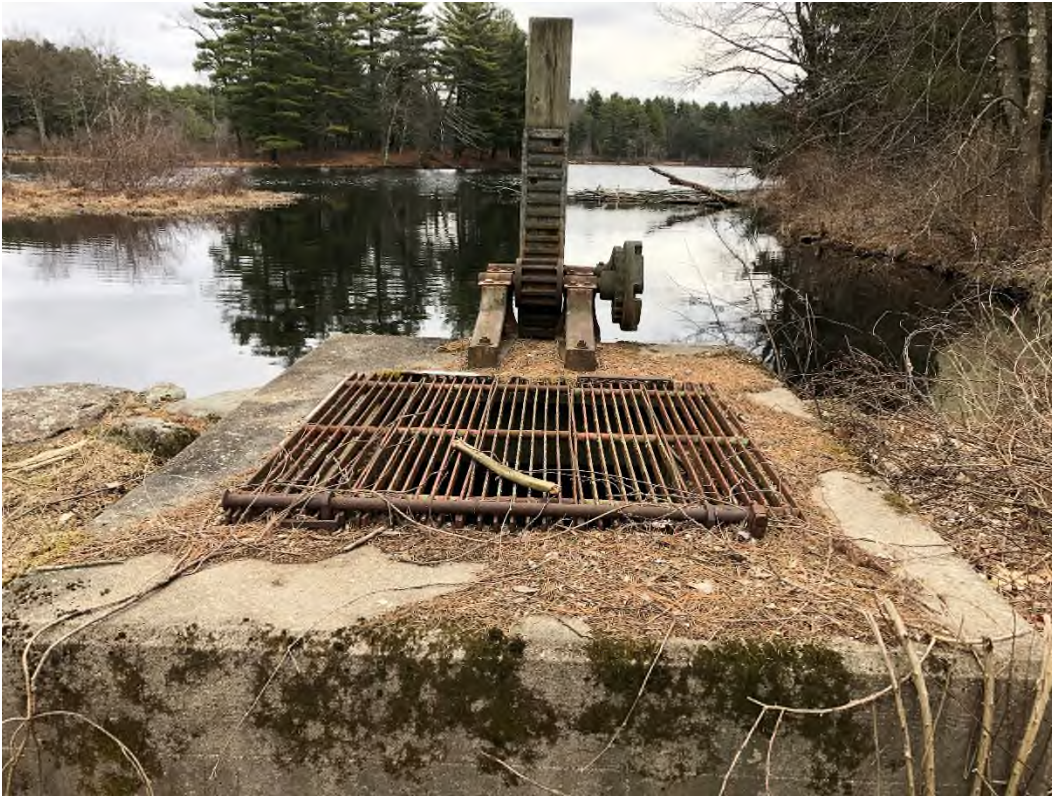
Photo 5 – Control gate structure viewed from downstream side looking into impoundment

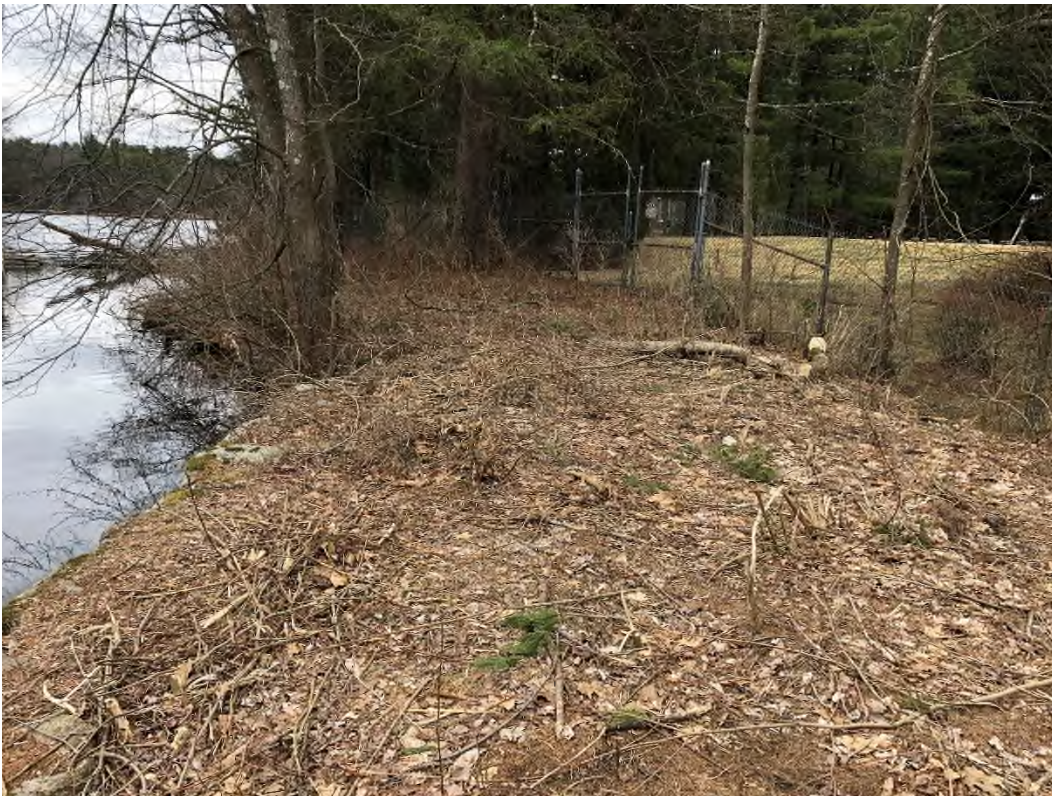
Photo 6 – Crest and view of left abutment
