- FORGE POND DAM & DIKE-
PHASE I
INSPECTION / EVALUATION REPORT

Dam Name: Forge Dam & Dike
State Dam ID#: 2-8-111-2 Dam & 2-8-111-3 Dike
NID#: MA00488 Dam & MA00489 Dike
Owner: Town of Granby
Owner Type: Municipal
Town: Granby
Consultant: Lenart Consulting Service, LLC
Date of Inspection: March 23, 2020

Executive Summary

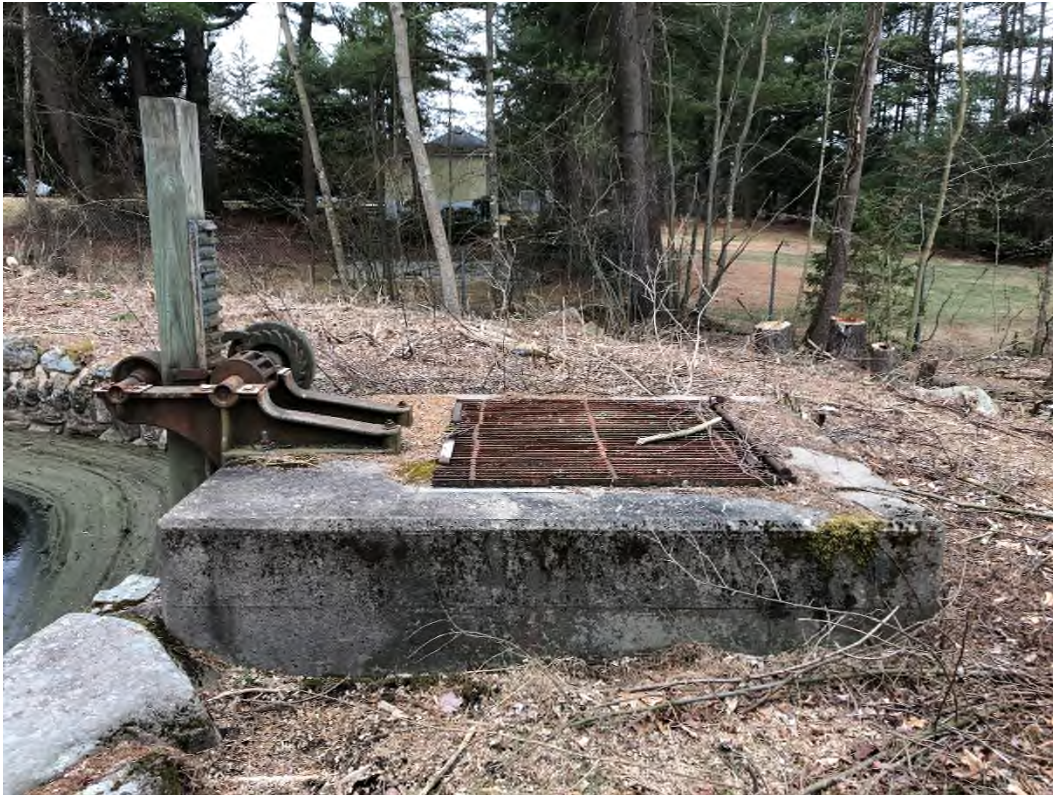
- Low Level Outlet (at Dike)
 - The sluice gate is operated with a rack and pinion system and is currently inoperable. The gate is in the closed position and materials of construction are deteriorated.

Photo 7 – Right side of rack and pinion level control gate structure

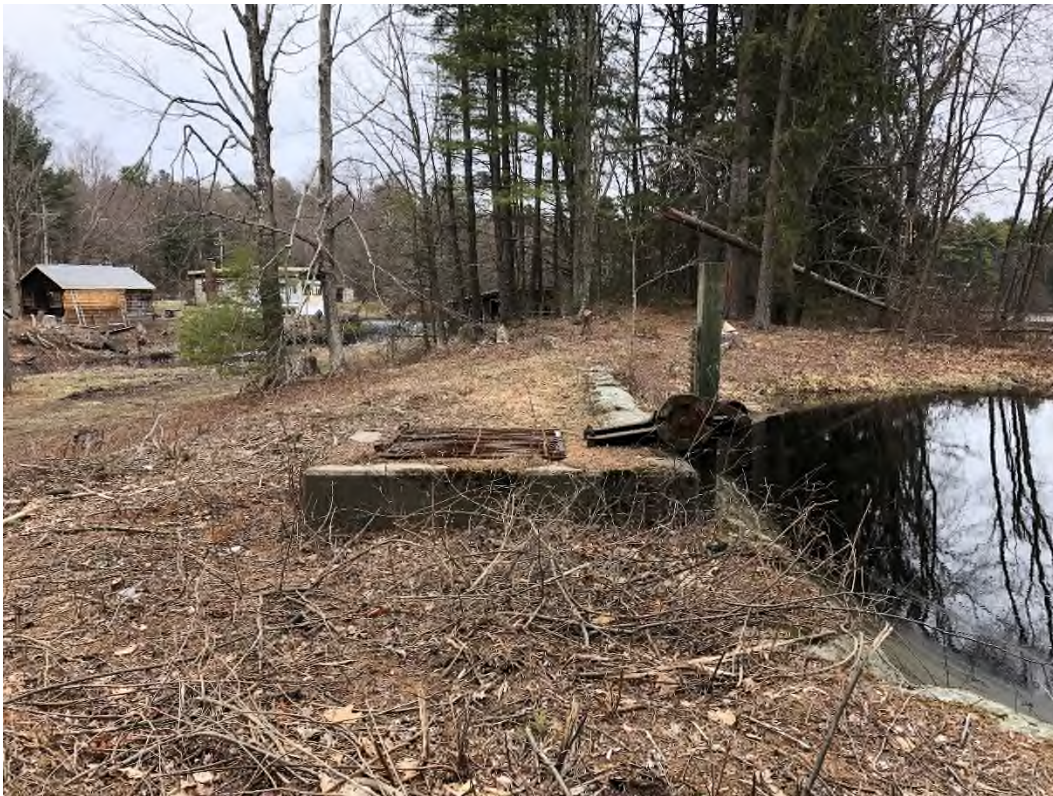
Photo 8 – Crest and low-level control structure viewed from the left side

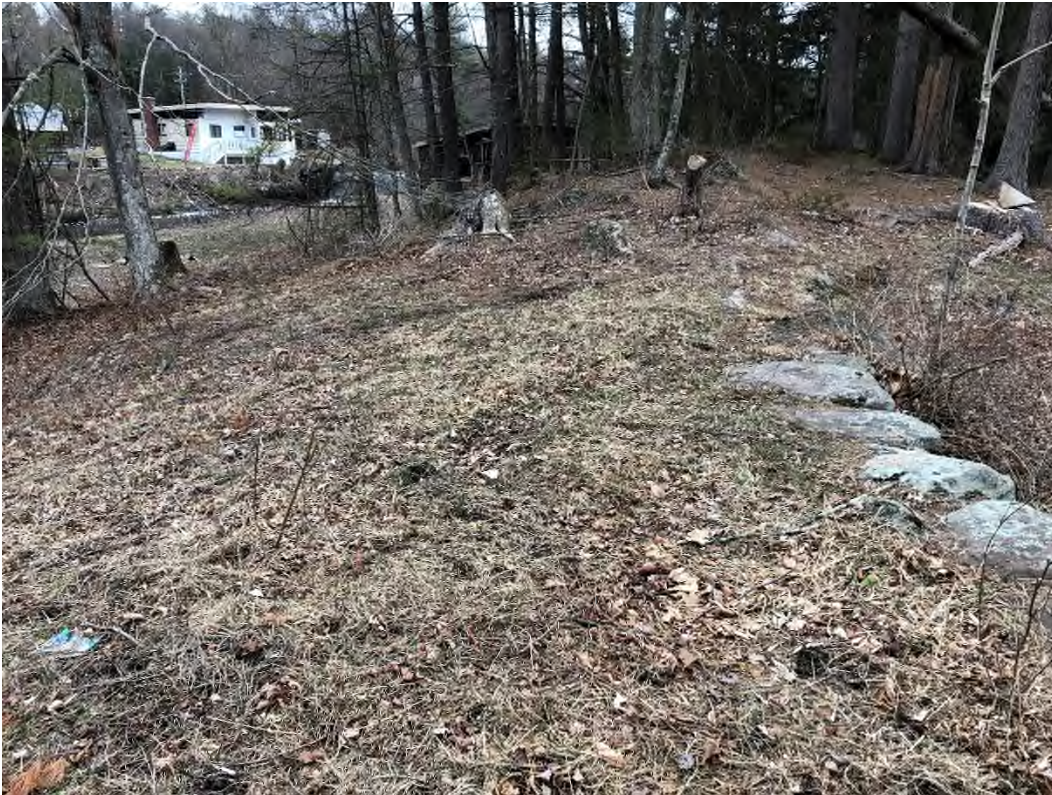
Photo 9 – Embankment crest at right abutment

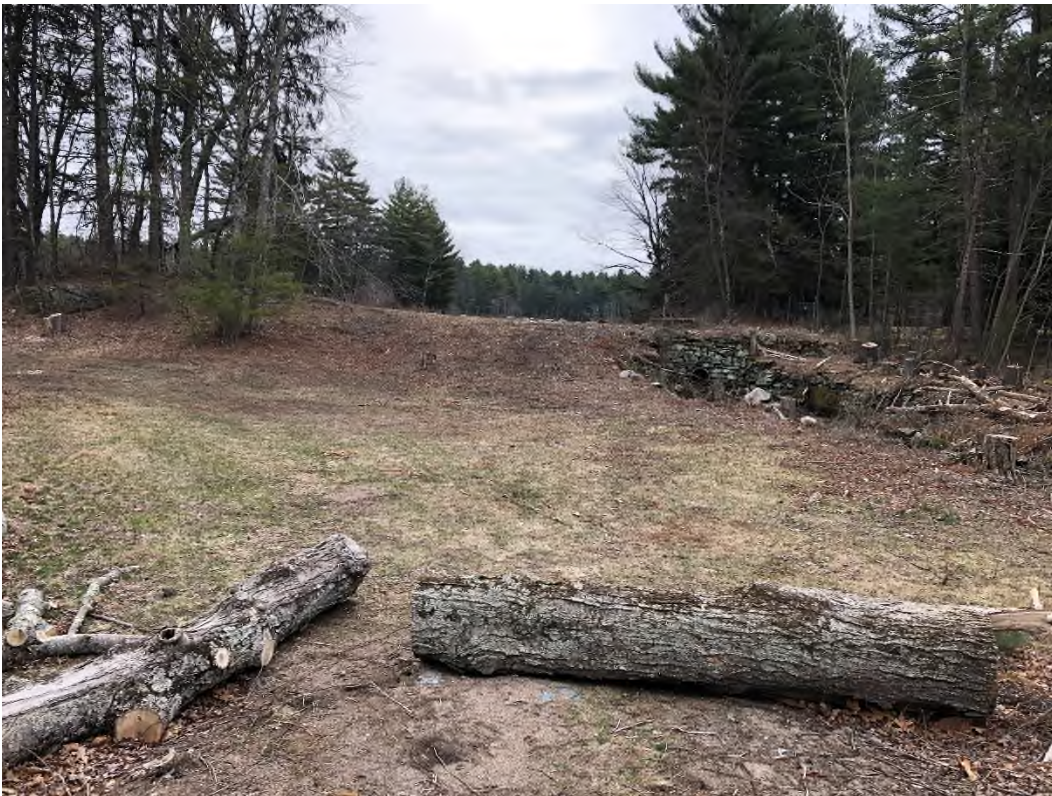
Photo 10 – Downstream slope at right side of dike

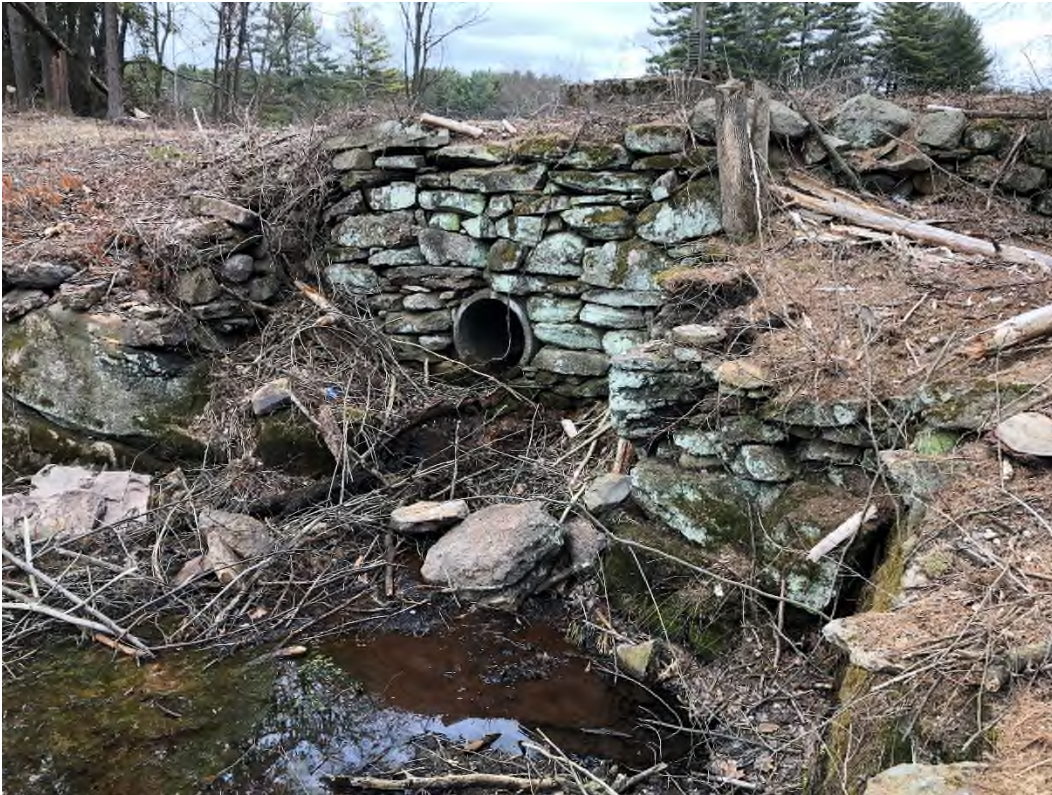
- Downstream of the outlet control structure there is a dry-stone masonry wall with the discharge of the 36-inch RCP low level outlet centered in the wall. A small amount of water is leaking past the gate and stop logs in the structure and discharging through the pipe.

Photo 11 – Downstream stone masonry retaining wall at low level outlet

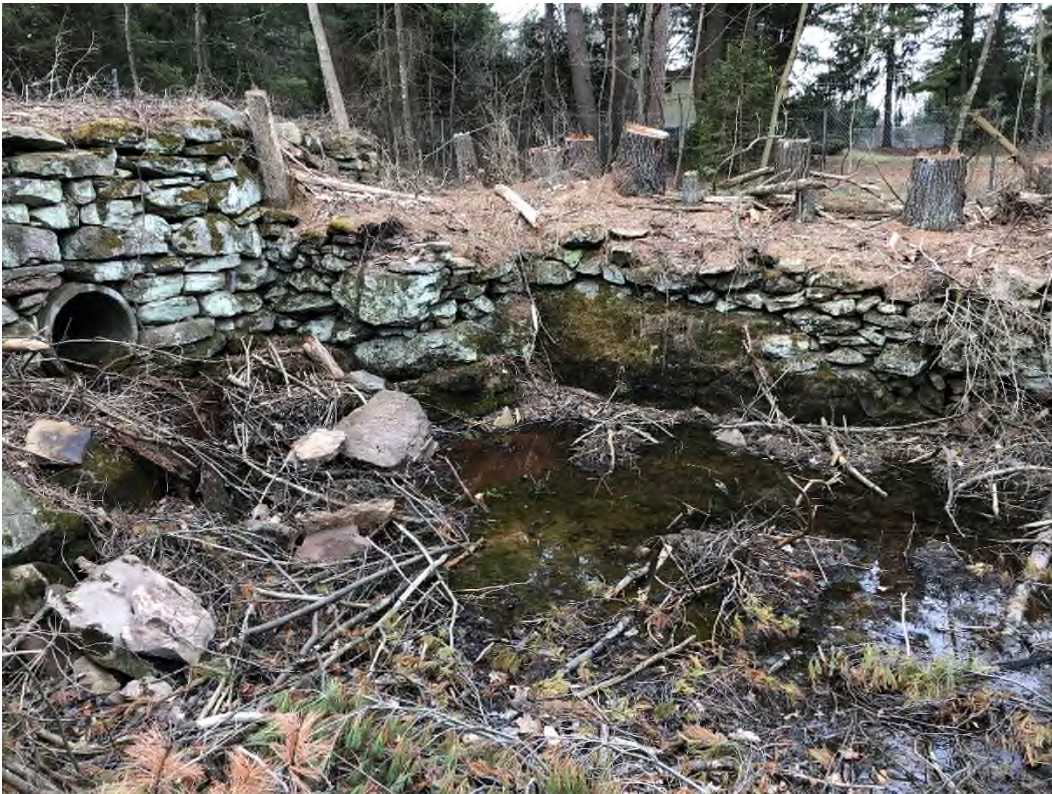
Photo 12 – Stone masonry retaining wall at discharge channel to the left of low level outlet

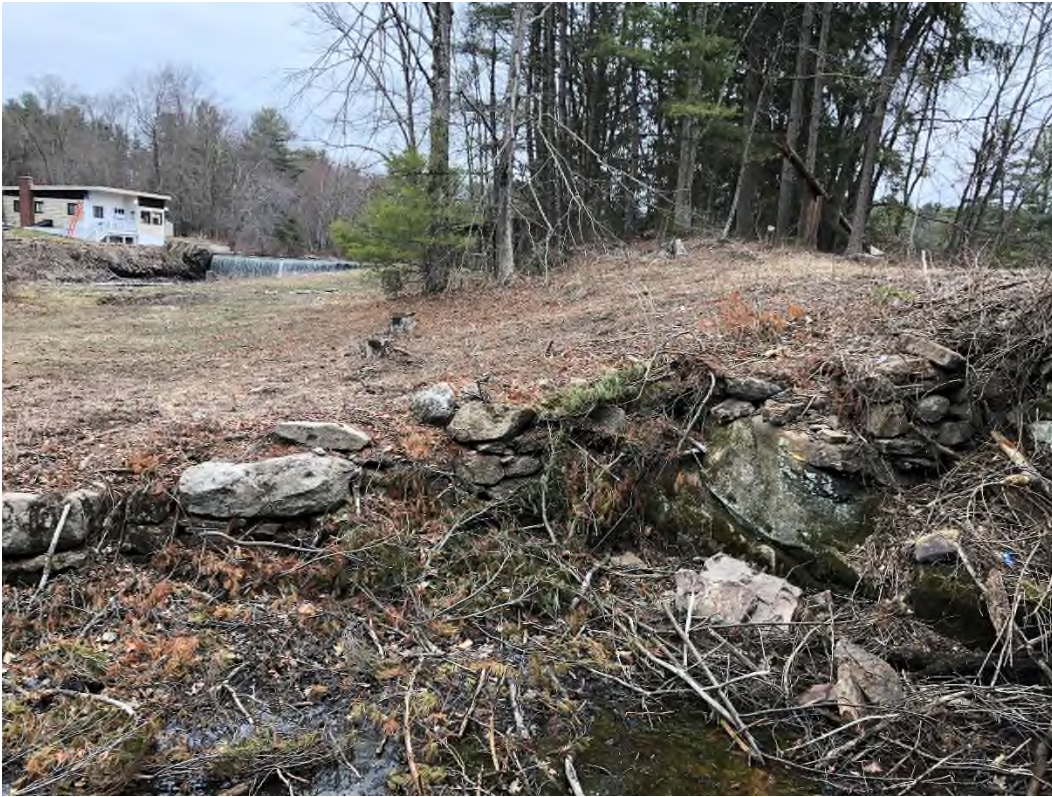
Photo 13 – Downstream stone retaining wall at discharge channel to the right of low level outlet

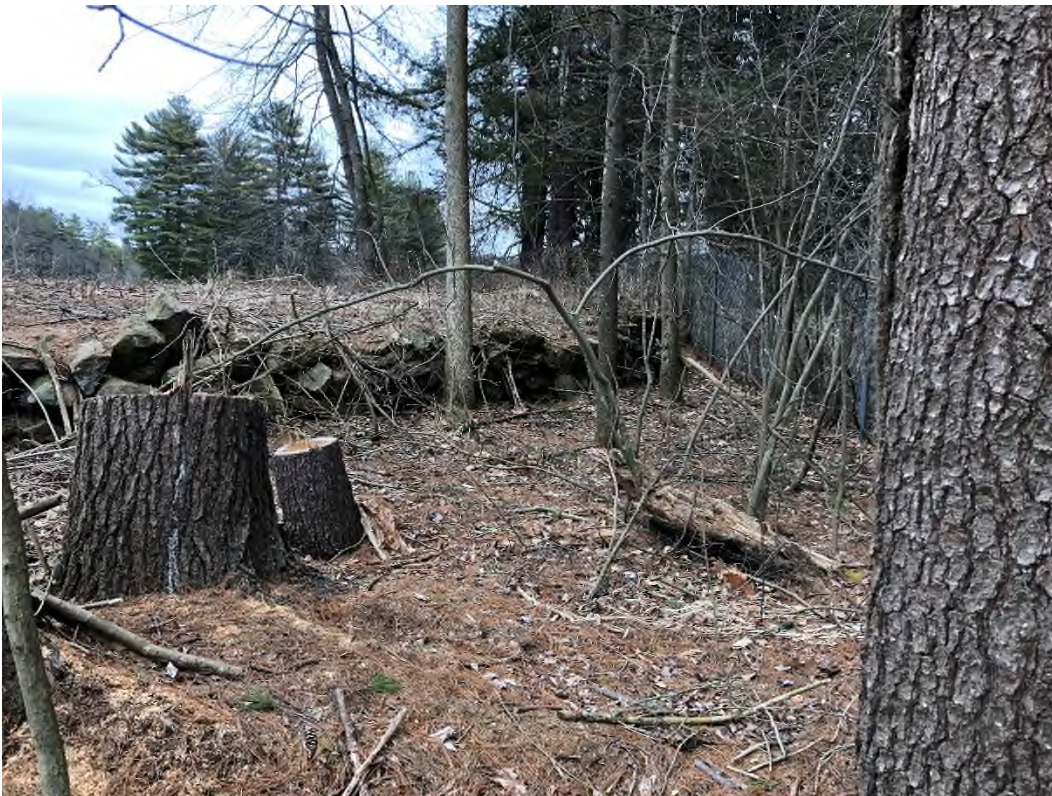
Photo 14 – Stone masonry wall on downstream slope to the left of the low-level outlet
Forge Pond Dike, Granby Date of Inspection: March 23, 2020

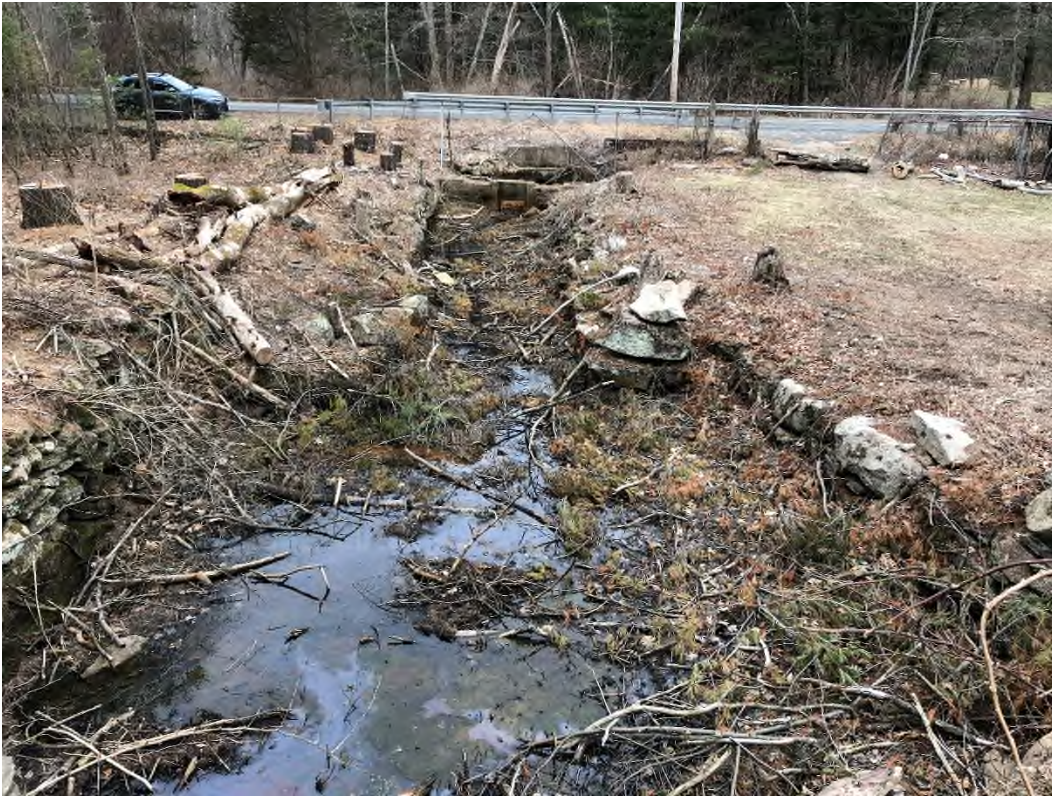
Photo 15 – Discharge channel viewed from the top of dike

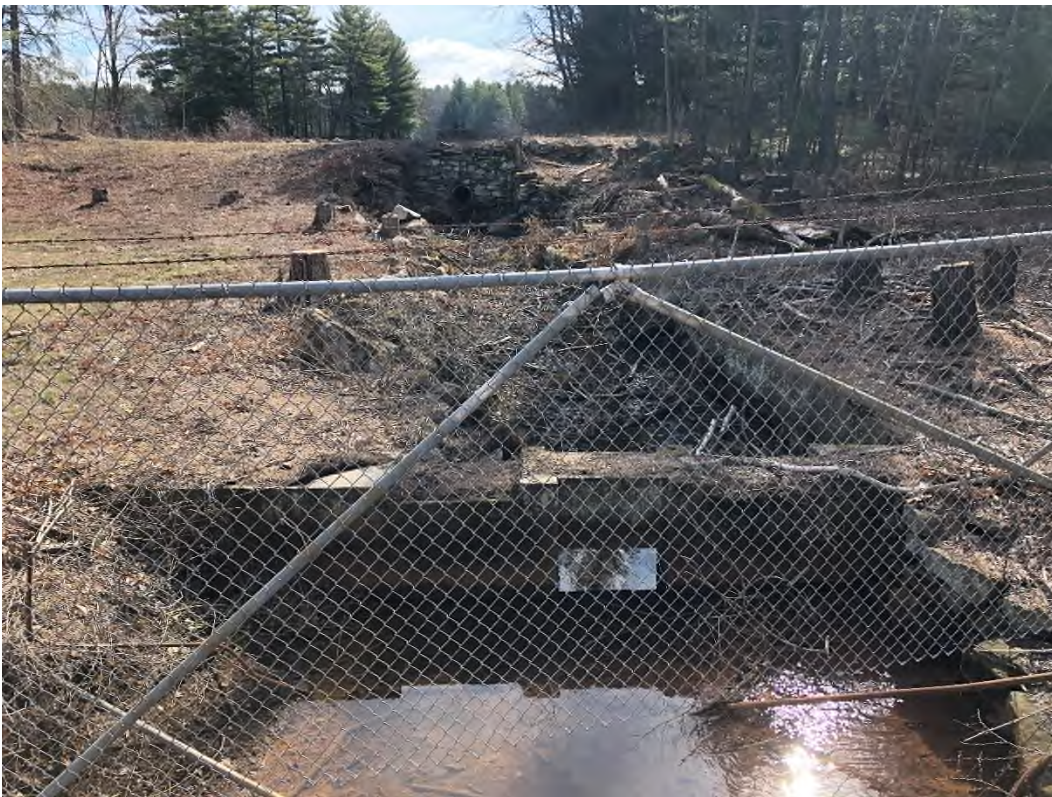
Photo 16 – Downstream overview of the dike from School Street

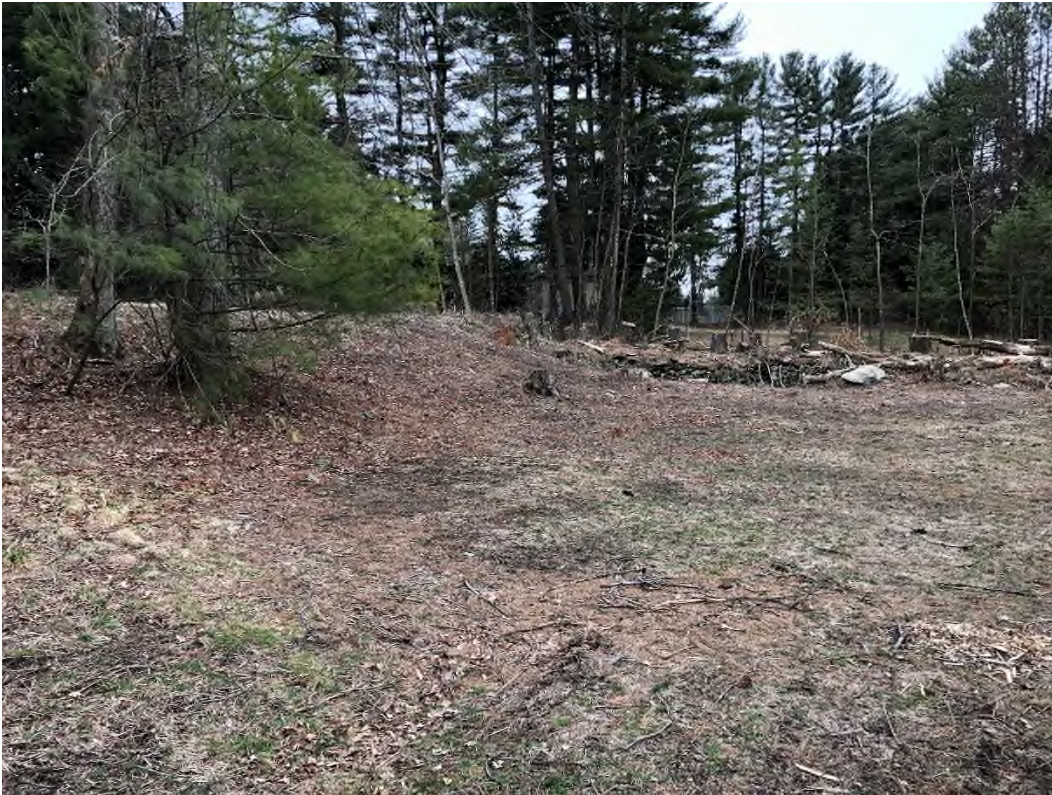
Photo 17 – Downstream overview of the dike from the right side

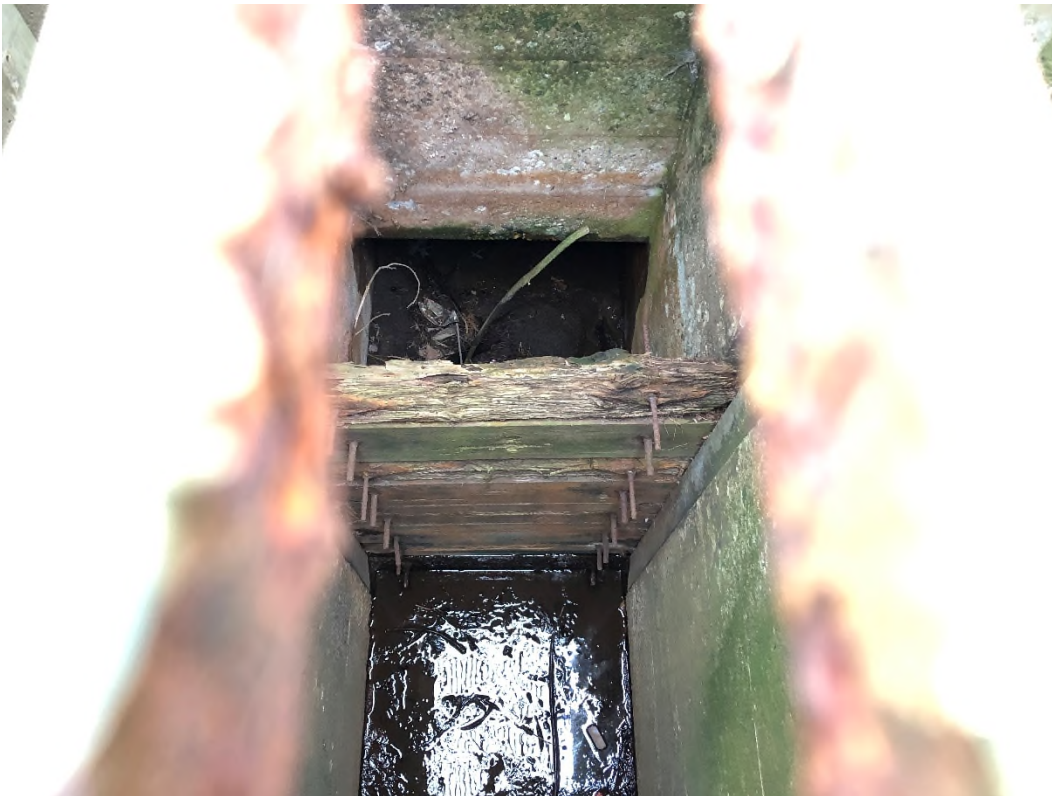
- The stop-logs within the structure were visible through the grating and show significant deterioration.
 - The structure was designed so that when the sluice gate was left in the open position, the stop logs within the outlet structure are utilized to control the impoundment level.

Photo 18 – Interior of low-level outlet structure looking downstream

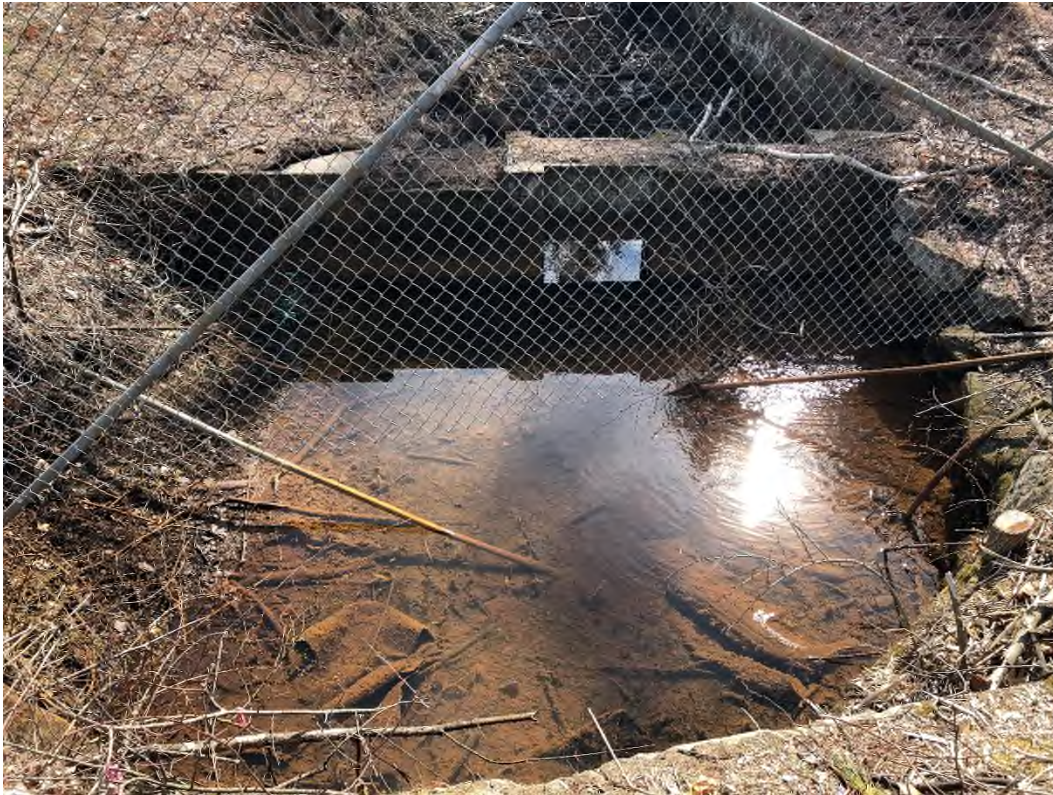
Photo 19 – Concrete weir in discharge channel downstream of the low-level outlet

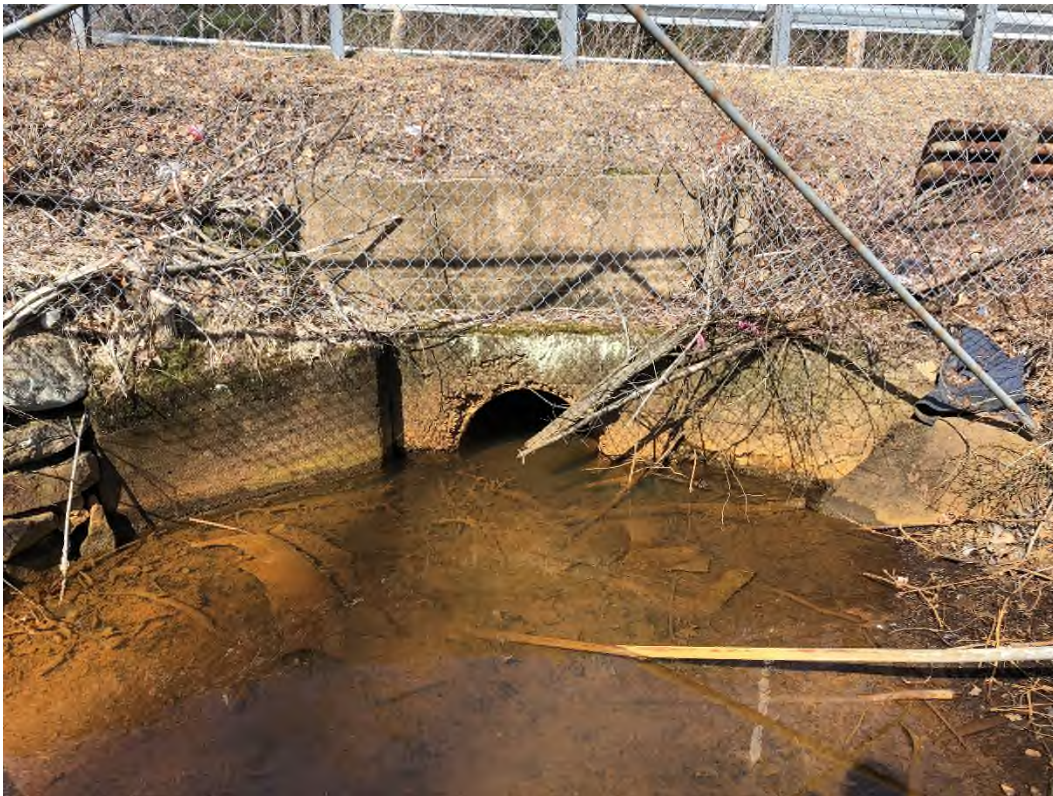
Photo 20 – Upstream end of culvert passing under School Street downstream of low-level outlet
