MEMORANDUM

TO:David Desrosiers, P.E., Highway Superintendent, Town of Granby, MAFROM:Julianne Busa, PhD; Rachael Weiter, EIT; Sarah Hayden, MScDATE:August 12, 2021RE:Stormwater Retrofit Plan

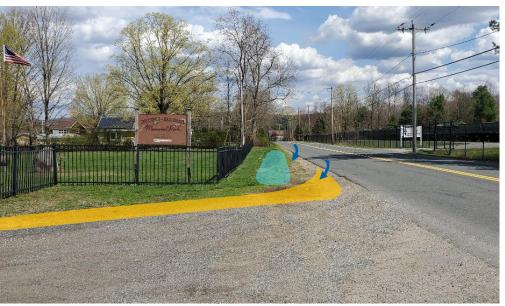
Image 3: Location of the proposed bioretention swale (blue) in the right-of-way east of the entrance to Brown Ellison Park. Restoration of grass ground cover and placement of boulders is recommended (orange) along both sides of the driveway.

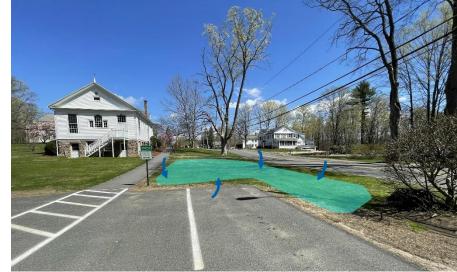
Image 3: Proposed L-shaped bioretention basin.
